Focus on Flange Faces

After the successful repair to one of the two main condensers on the USS Austin (LPD-4) in Gibraltar, one of its sister ships - there are a total of 11 vessels in the Class - the USS Shreveport (LPD-12), was experiencing similar problems while stationed in Norfolk, Virginia.

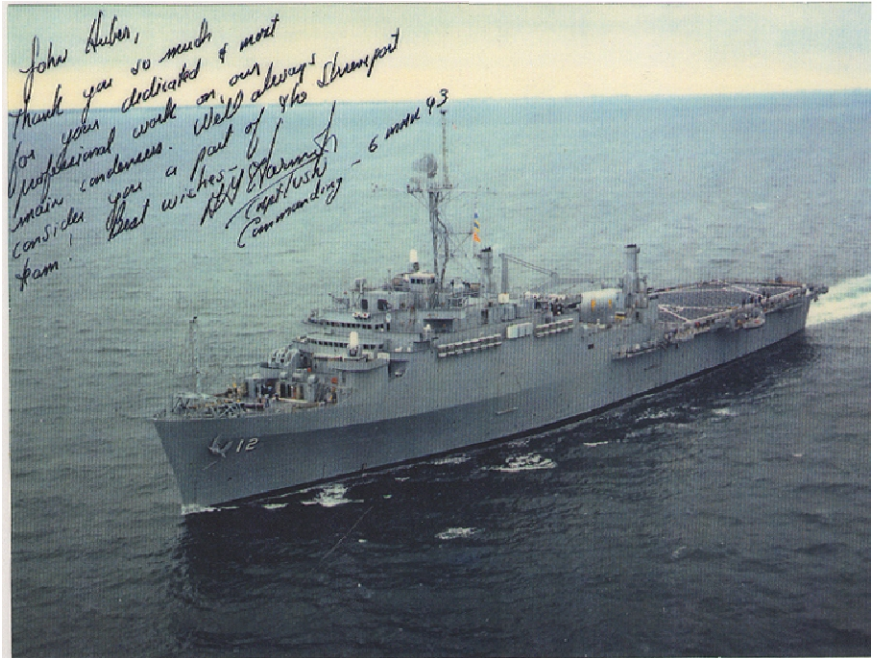
After pulling the boxes, the damaged areas of the flange faces were thoroughly roughened using grinders to cut a coarse "hash marked" pattern in the surfaces.

Release Agent was used on the former to rebuild the corroded faces back to the proper shape.

After mixing the CeramAlloy CP+ and applying it to both the

roughened flange face and to the inside of the former, the former was positioned over the flange surface.

Using clamps to draw the former in and squeeze out the excess material, the flange face was rebuilt to the required size, shape and contour, thereby ensuring that the proper seal between the water box and the mating surface on the tube sheet could be achieved without the need for traditional, costly welding and machining procedures.
