Enecon North East News
Feb. 2016 | Vol 8, Issue 1

A Utility 30" Salt Water Line Repaired Using Carbon Fiber

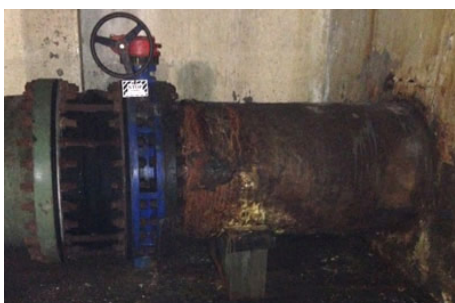
At a Northeast Power plant has a 30" main salt water inlet line that ruptured requiring an emergency outage and shutdown. The facility turned to the **ENECON** emergency response team to provide a proposal for the preparation and application of the **DuraWrap Carbon Fiber encapsulation system** that would externally reinforce the 30 inch diameter salt water service line. The facility was concerned with the condition of the pipe, and if it failed it could force a long shut down to replace the pipe.
