Enecon North East News
 July 2013 | Vol 5. Issue 8

Pennsylvania Hospital Stops Leaking Dishwashing Tray Seams in their Kitchen with FLEXICLAD ER

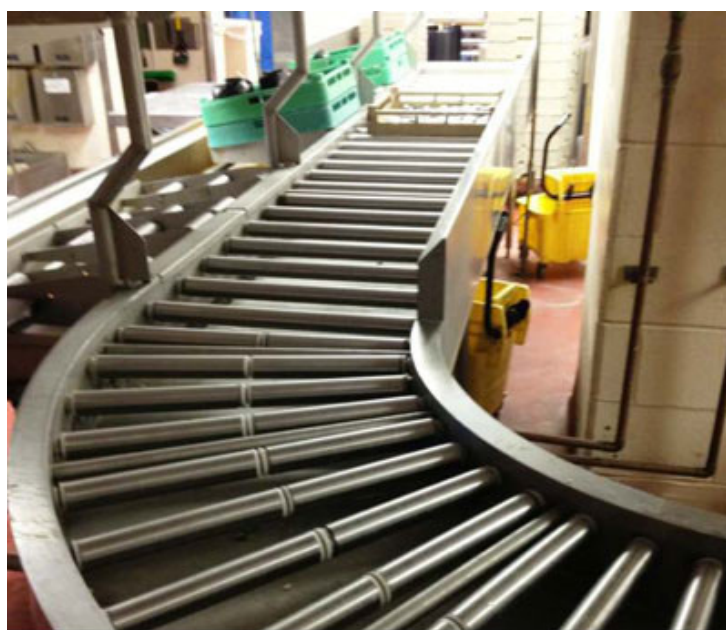
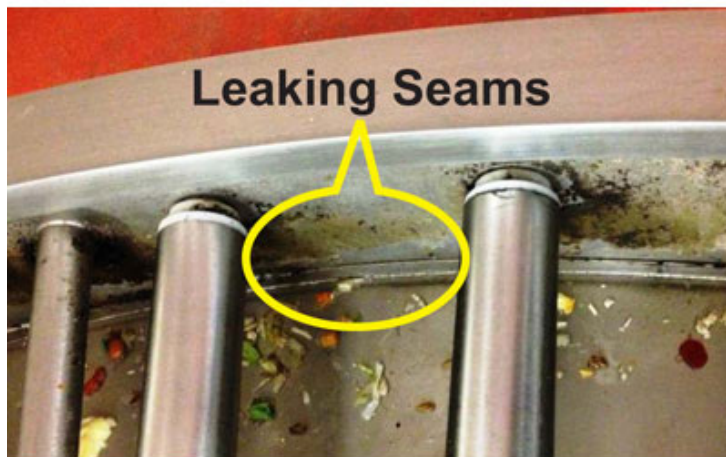
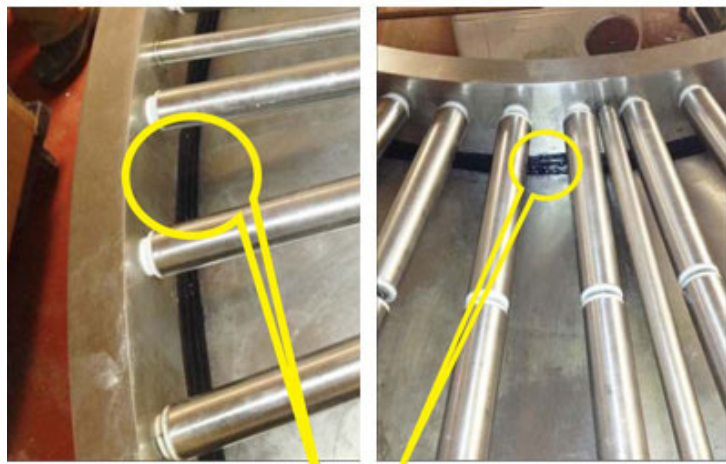
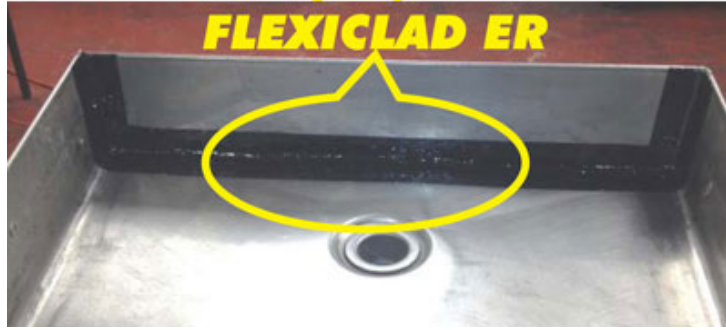
The hospital's maintenance engineers contacted the local ENECON Fluid Flow Systems Specialist with what they considered an 'unusual' problem. The seams of their stainless steel dishwashing tray line were leaking. This was causing slip/fall accidents, constant clean-up and generally unsanitary conditions. They had tried to fix the leaks numerous times with caulks, but with no success. It was quickly agreed that FLEXICALD ER would be used to solve this problem. The area's were manually prepared with sandpaper, then cleaned throughly. FLEXICLAD ER was applied, with no primer needed. The area was ready to be put back into action the next morning with no odor and no downtime.

The hospital maintenance staff was pleased with the results and ENECON continues to be the hospital's 'problem solver'.
