Enecon North East News
Nov 2013 | Vol 5, Issue 12

**ENECRETE & ENESEAL Repair Fire Damaged
Concrete Bases of 37 Ton Transformers**

Client: Northeastern U.S. Municipality

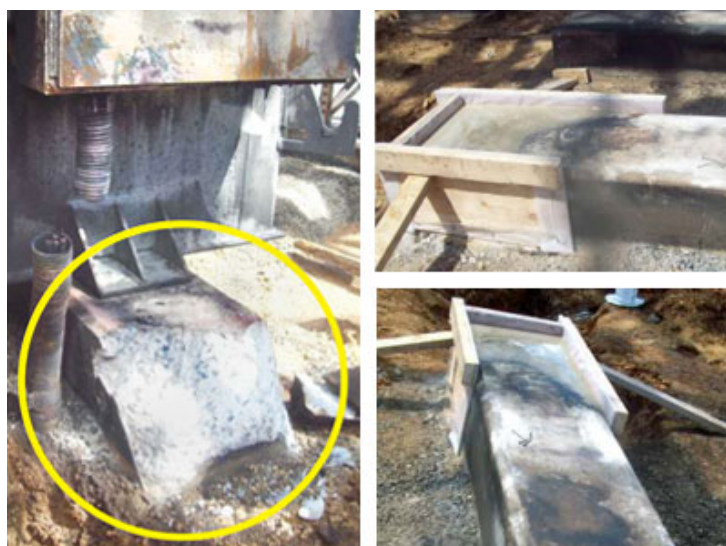
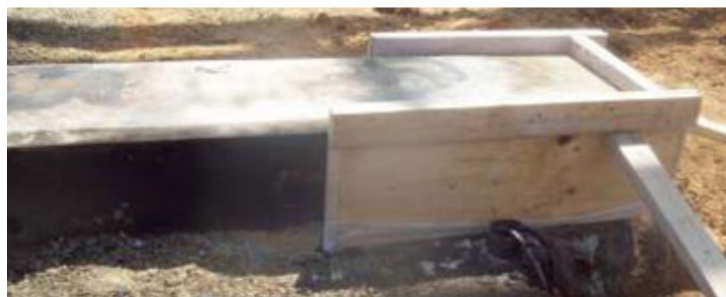
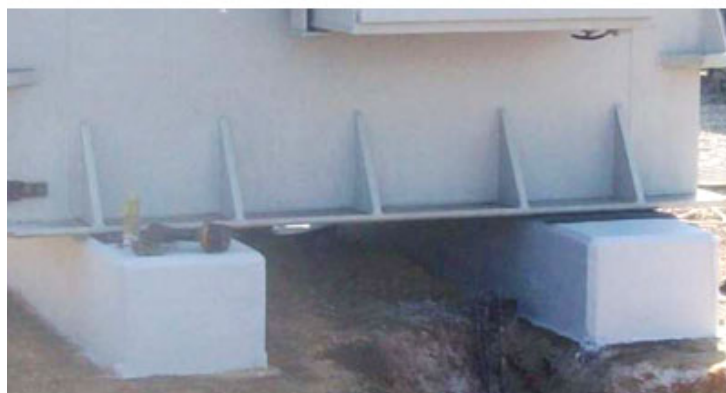
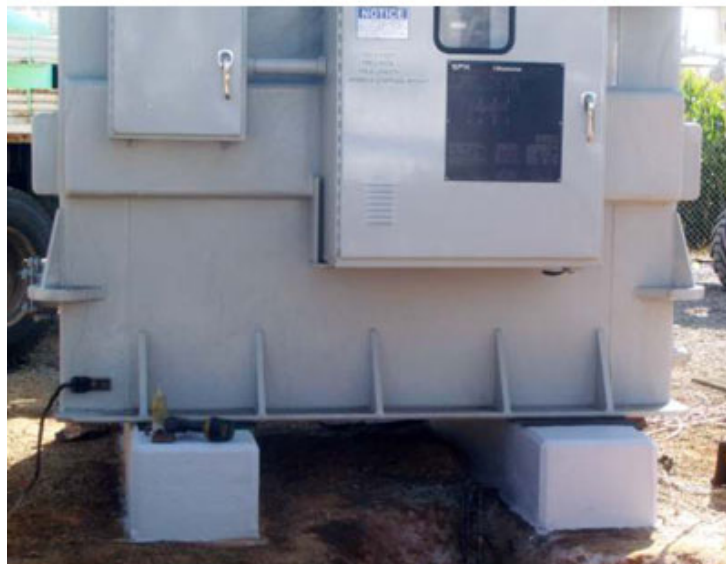
Problem: 2 Power transformers were involved in an accidental fire causing them both to have to be removed and eventually replaced. The onsite engineers were concerned about the integrity of the concrete bases the 37 ton transformers were mounted on. Cracks and damage were visible after the transformers were removed.

Solution: Loose concrete was removed from the bases as the area was manually prepared. Wood forms were built around the bases and **ENECRETE DuraFill**, mixed with a locally sourced aggregate, was used to repair all the damaged areas. **ENESEAL CR** was then applied to give the bases a uniform look as well as protect them from future environmental exposure. The engineers were pleased with ENECON's ability to provide a cost effective solution for this very serious problem.
