CHEMCLAD XC "Cures" Shower Stall Problems at New Jersey Hospital

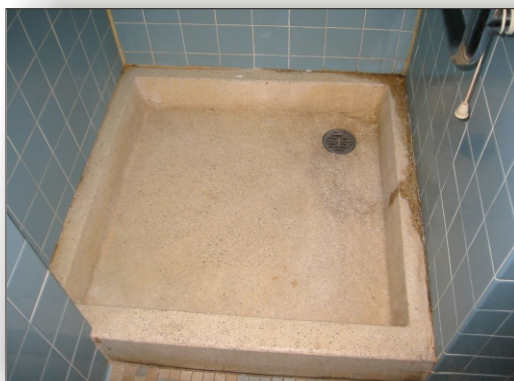
Worn, pitted basins were unsightly & impossible to clean.

After years of constant use, the basins had become worn and pitted and the original sealer finish was gone. The basins were nearly impossible to clean and unsightly as well. Patients were reluctant to use the showers. Since occupancy is as important to a hospital as to a hotel, each shower had to be completed in one day as rooms became available.

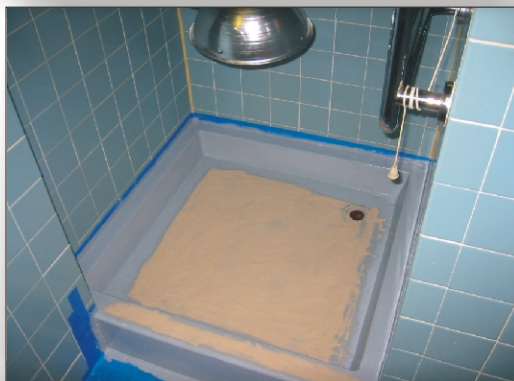
Heat lamps were used to accelerate the cure of the first layer of CHEMCLAD XC

A first layer of CHEMCLAD XC was applied by brush and roller. An anti-slip aggregate was broadcast into the uncured CHEMCLAD XC. This filled in pits in the concrete surface and improved the safety of the showers. After sweeping up the excess aggregate, a second layer of CHEMCLAD XC in the finished color was applied.

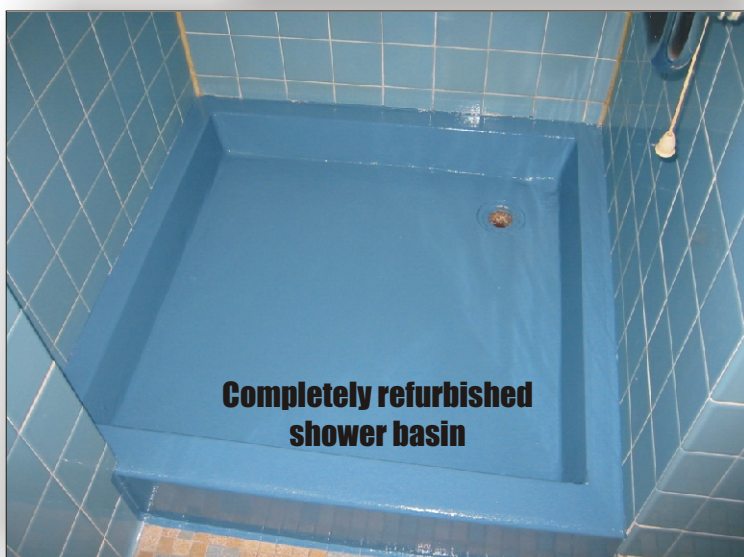
Completely refurbished shower basin

The finished basins have an easy-to-clean and safe "diving board" finish. Over 80 showers have received this treatment.
