Enecon North East News  
Dec. 2015 | Vol 7. Issue 10

### CeramAlloy Coated Pump Impellers Look Like New After 10 Years in Service on a 680 ft. Alaskan Fish Processing Ship

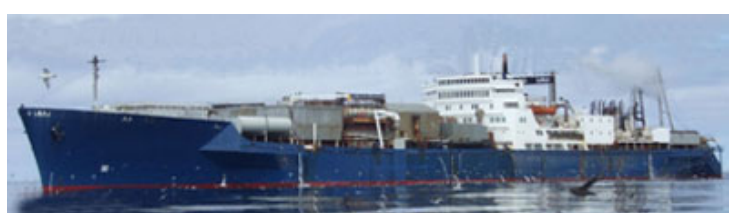
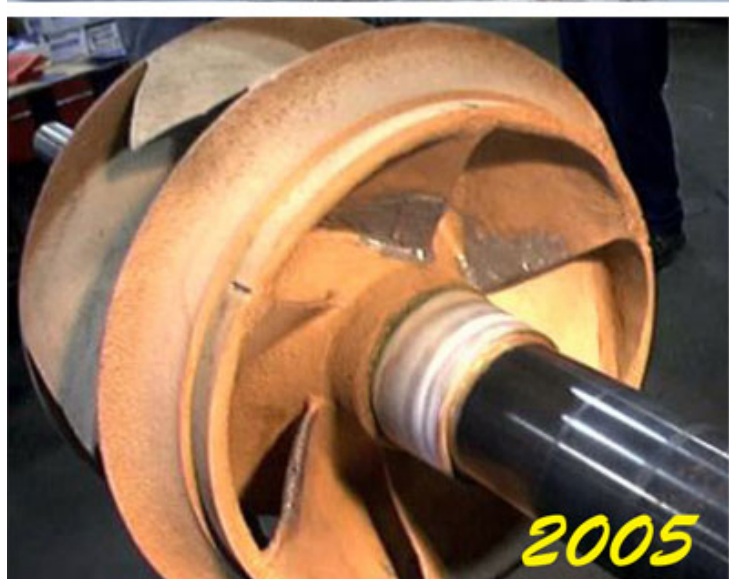
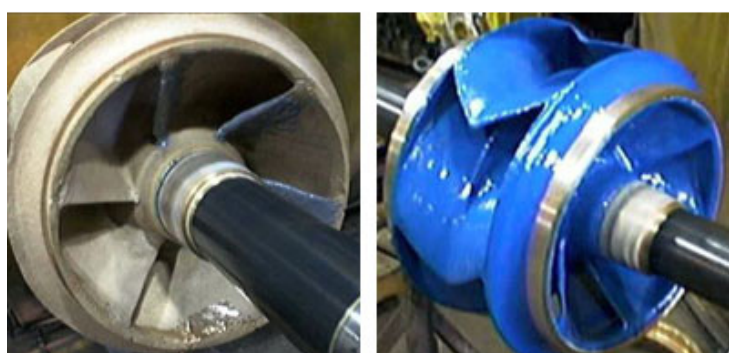
In 2005, ENECON was contacted to repair and protect an impeller for a large split case cooling water pump. Because of its outstanding performance in erosion / corrosion environments, CeramAlloy was selected to complete these repairs.

After grit blasting, the severely damaged leading edges of the vanes were rebuilt using stainless steel mesh and CeramAlloy CP+AC. The entire impeller was then protected with two layers of CeramAlloy CL+AC.

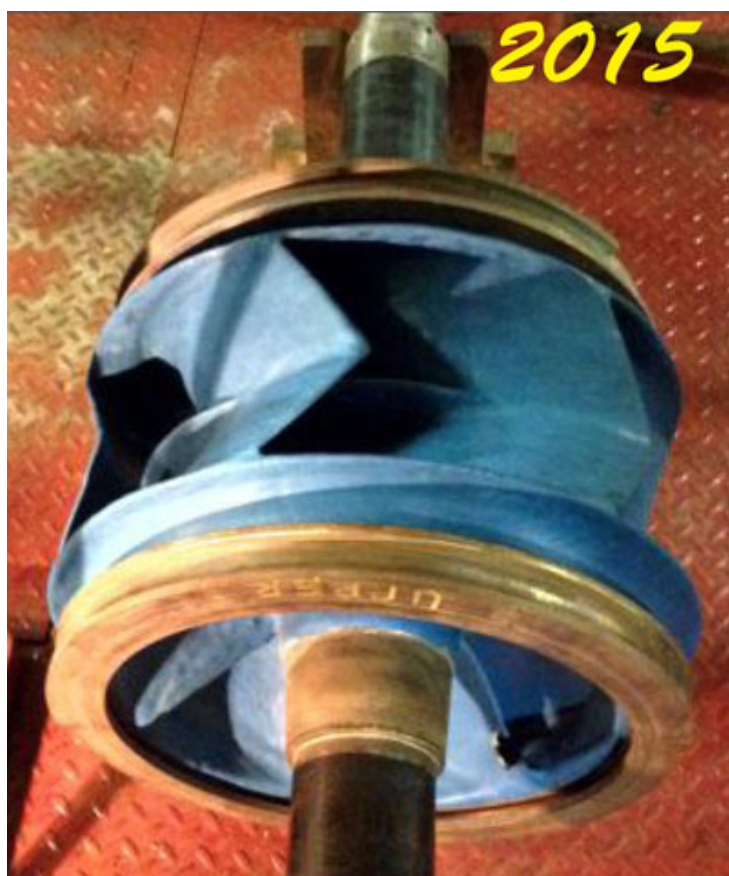
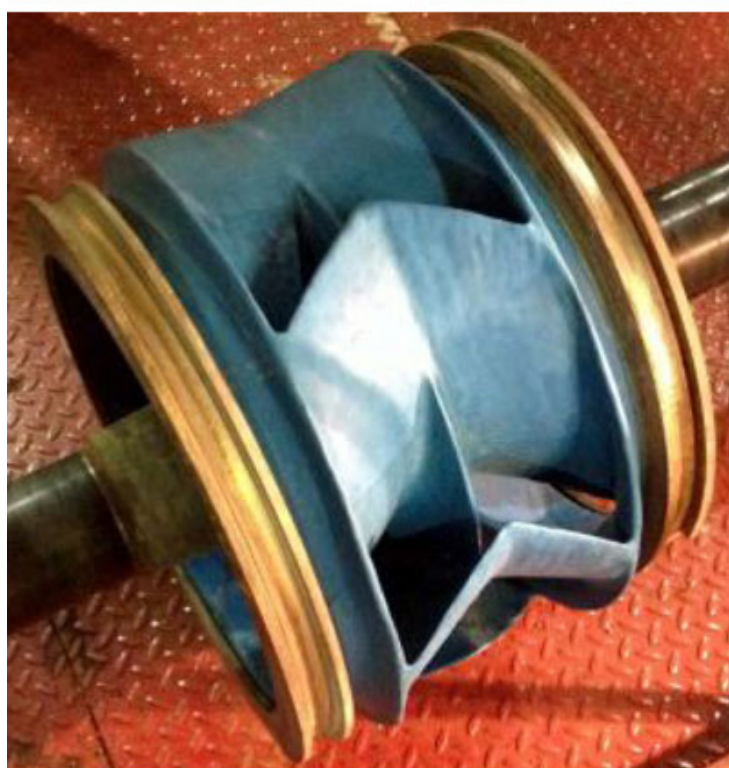
Although the vessel's maintenance logs confirm that the impeller did not have any maintenance performed for 10 years, it is clear from the photos below that the CeramAlloy is still in excellent condition.
