Enecon North East News  
June 2016 | Vol 8, Issue 4

## Municipal Water Tank Repaired and Protected with ENESEAL CR

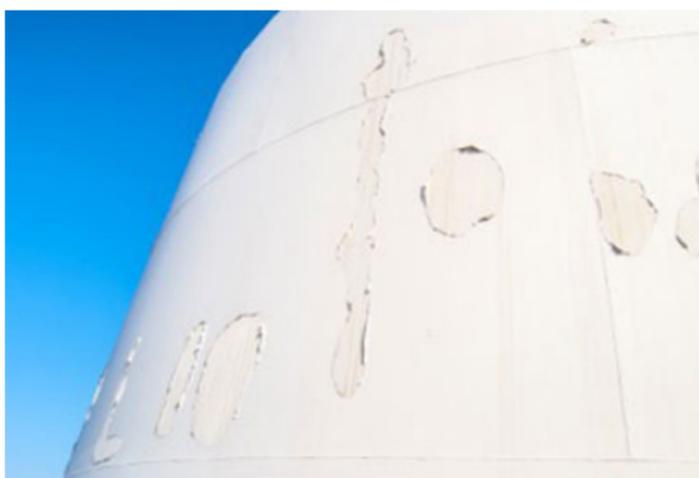
This customer's municipal water tank was corroding and in overall disrepair. Due to UV exposure, the existing coating was also delaminating, causing further deterioration.
