Enecon North East News
Nov. 2016 | Vol 8, Issue 10

Corroded Steel Cooling Tower Support Beams Are Protected With ENESEAL CR

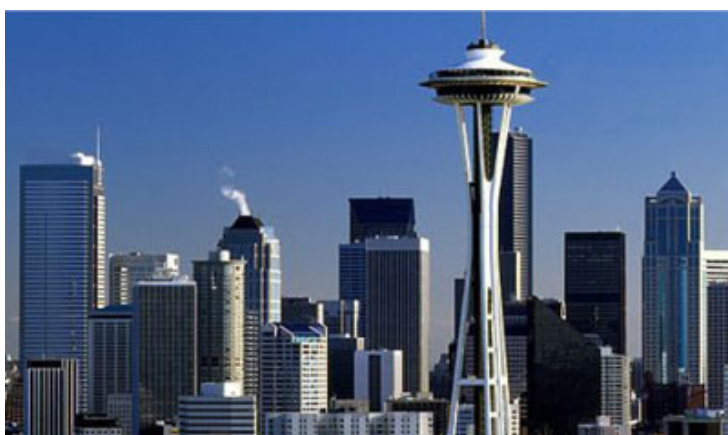
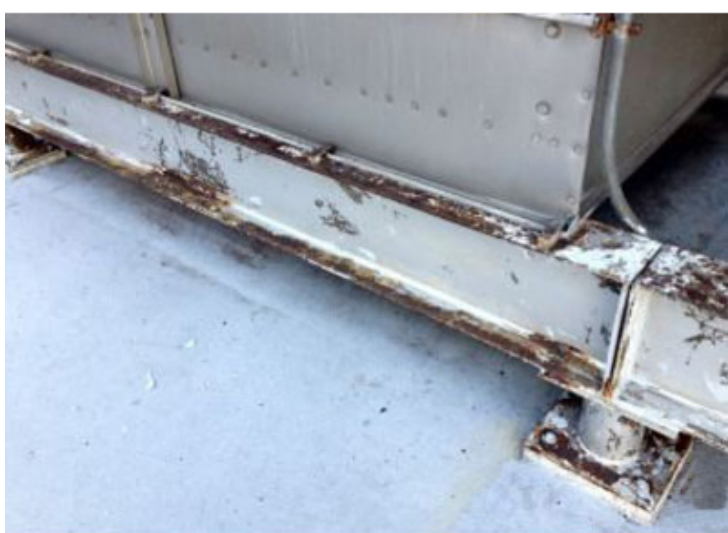
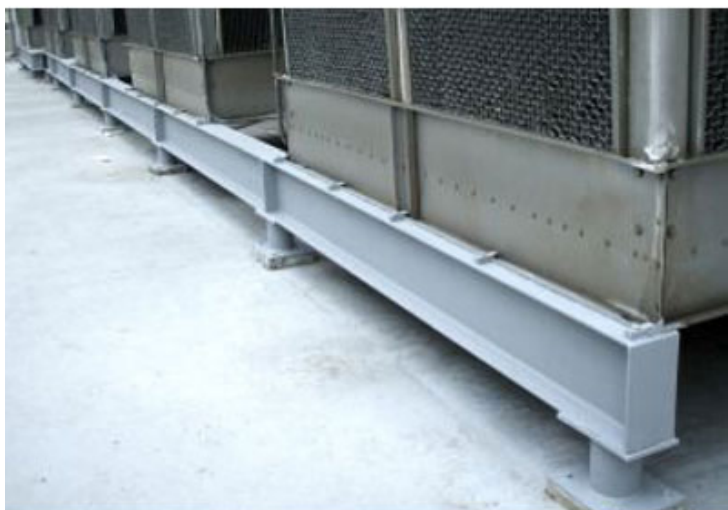
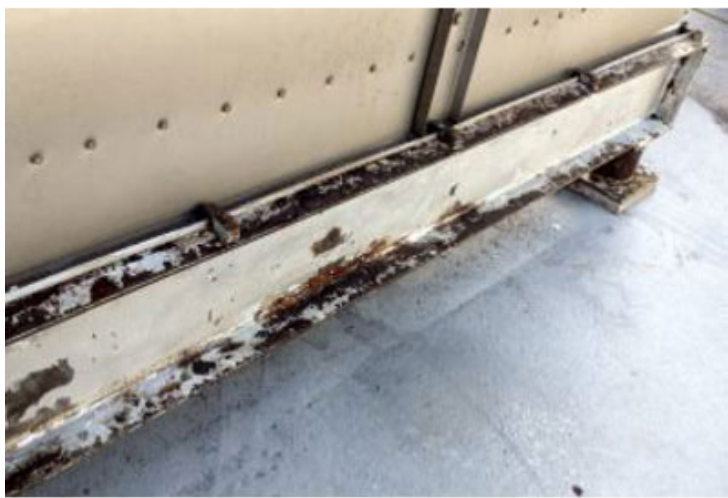
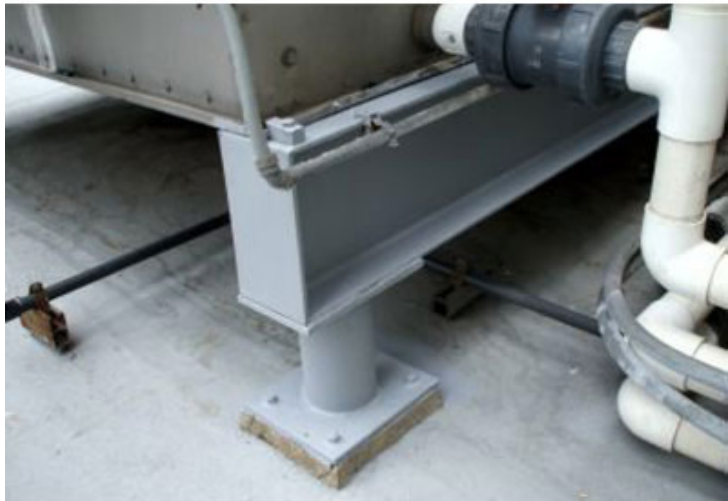
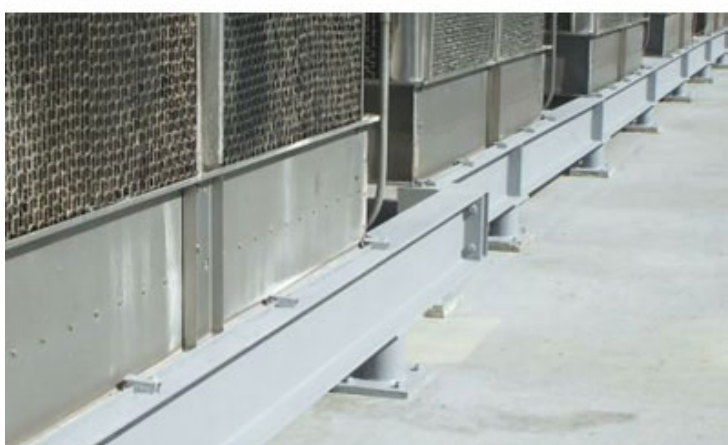
A downtown Seattle office building has these large cooling towers on top of galvanized support beams. The beams were corroding due to the environmental conditions in which cooling towers historically operate.

The support beams pictured had been painted with a "high quality" marine paint just one year prior to this project taking place. The previously applied paint was already peeling off due to the prior coatings' inability to bond to the galvanized surface of the support beams.

The beams were first prepared by pressure washing and then hand grinding was used to remove any remaining paint and rust. Once the surface was properly prepared, two coats of ENESEAL CR, tinted to a custom gray color, were applied to provide long term corrosion resistance.
