Enecon North East News
 Feb. 2017 | Vol 9. Issue 2

CeramAlloy HTL Used to Repair & Protect High Temperature Pulp & Paper Mill Rollers

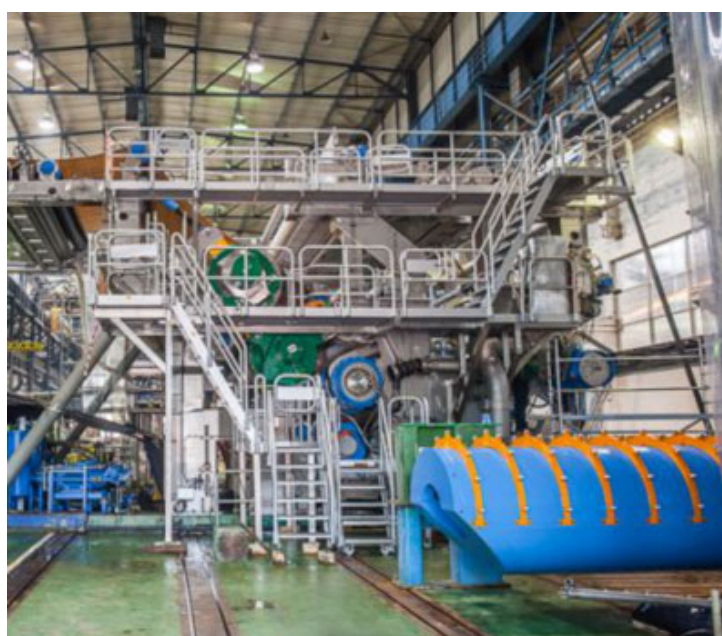
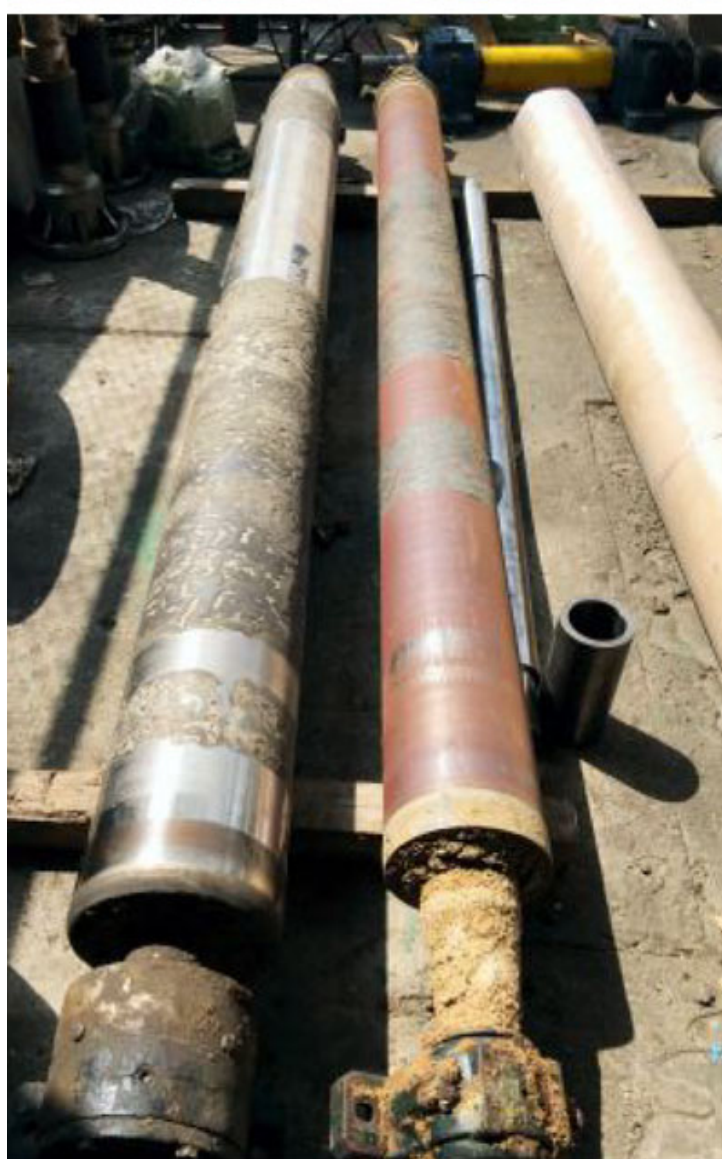
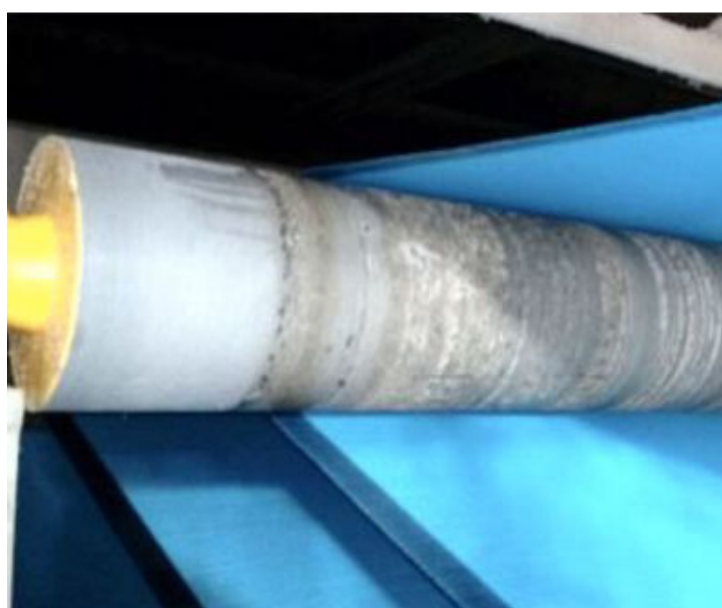
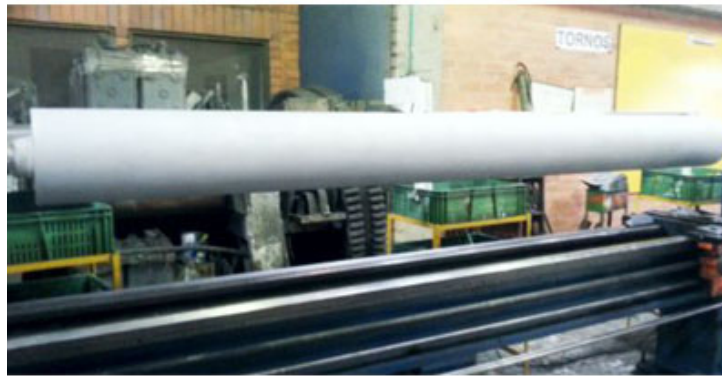
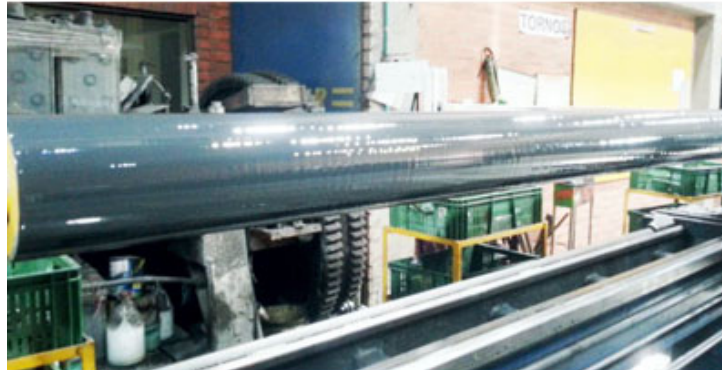
A major corrugated carton manufacturer in Colombia was faced with the issue of having to resurface their production rollers every 30 days. If roller diameters get too low, they need to be replaced entirely.

ENECON Colombia was asked to help find a solution to this problem by repairing two 'test' rollers. The rollers operate at a potential maximum temperature of 302°F/150°C.

The rollers were prepared by grit blasting. Two coats of CeramAlloy HTL were then applied to completely resurface the rollers.

Each roller requires 4kg of CeramAlloy HTL. Previous repair methods of metalizing would cost \$3,000USD per roller. ENECON's CeramAlloy HTL cost half the price. Additionally, the ENECON solution cut maintenance time of these rollers significantly.
