Corrosion Problems on Panama Canal Tugboat Pump

Enecon North East News
April, 2017 | Vol 9, Issue 4

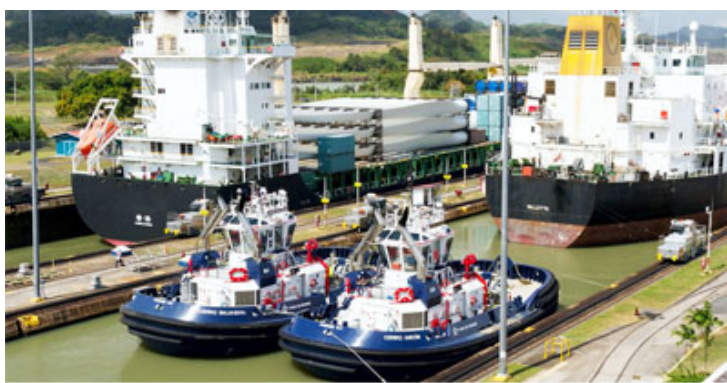
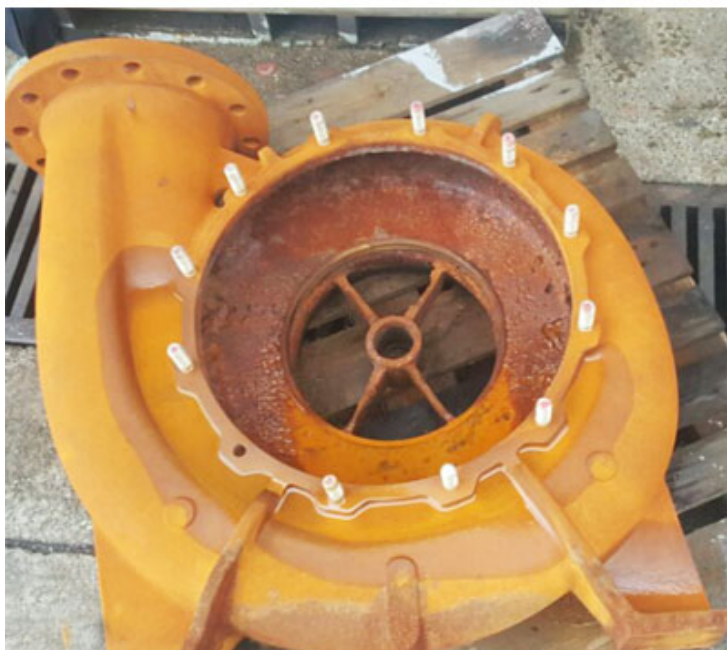
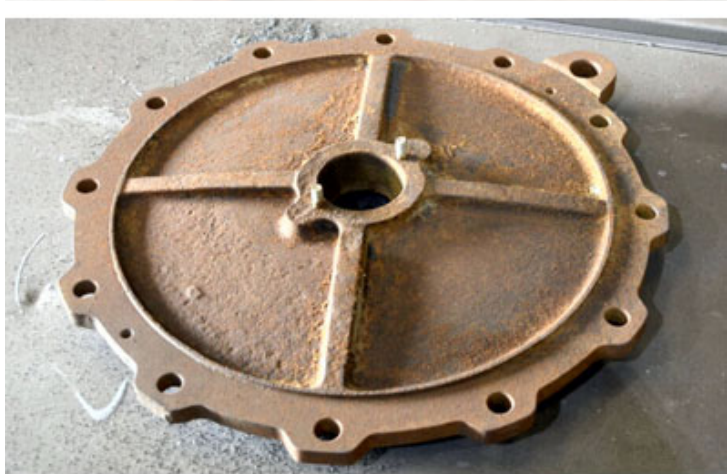
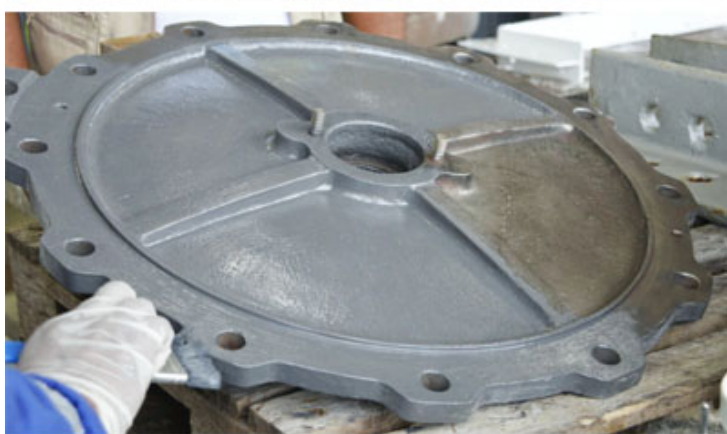
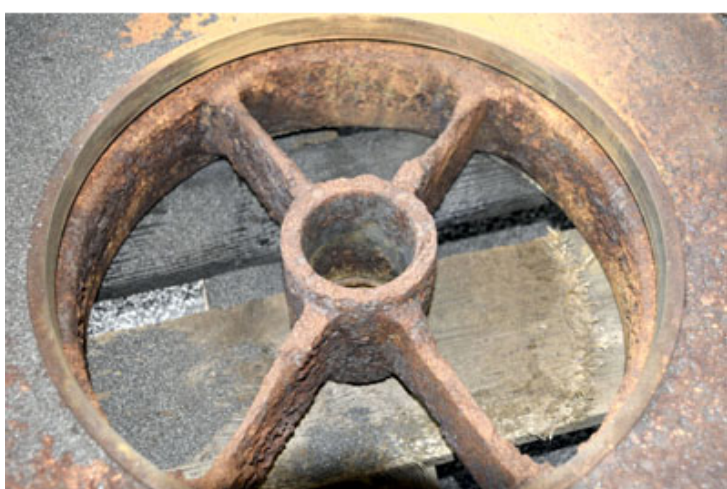
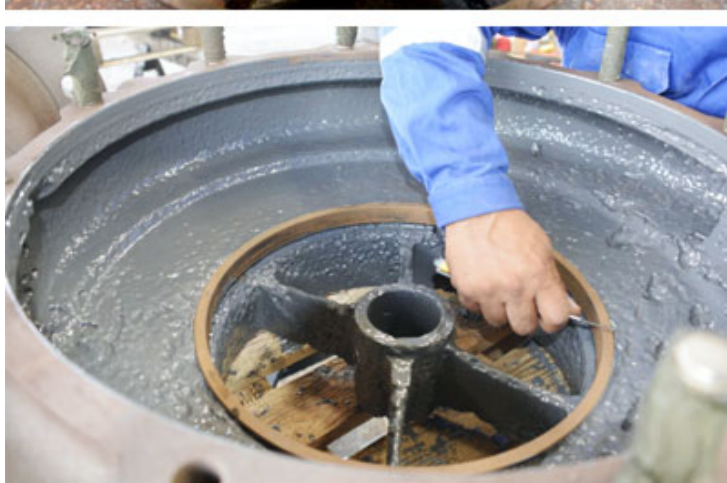
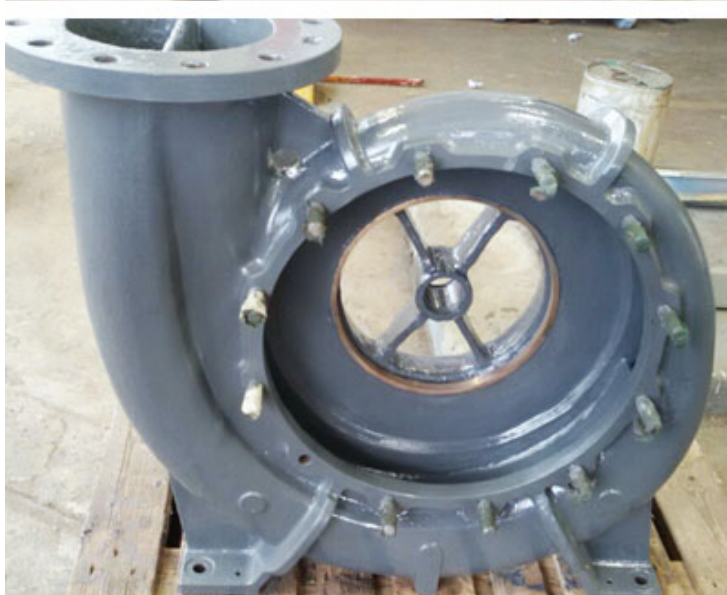
At the Panama Canal, a fleet of tugboats assists ships passing through the newly expanded locks. Each of the tugboats have pumps like this one, which pump salt water.

Constant exposure to salt water caused the entire surface of this pump to suffer from erosion and corrosion. This caused a weakening of the metal which then reduced the pump's efficiency in addition to leaks at the seams.

After grit blasting the pump and all of its components, a first coat of CeramAlloy CL+AC was applied to wet out all surfaces. CeramAlloy CP+AC was then used to rebuild the weakened and damaged areas. Then a final layer of CeramAlloy CL+AC was used to protect the pump from future erosion and corrosion problems.
