Enecon North East News
 Mar 2014 | Vol 6, Issue 4

Northeastern U.S. Power Company Protects Switchgear Cabinet Roofs with ENESEAL

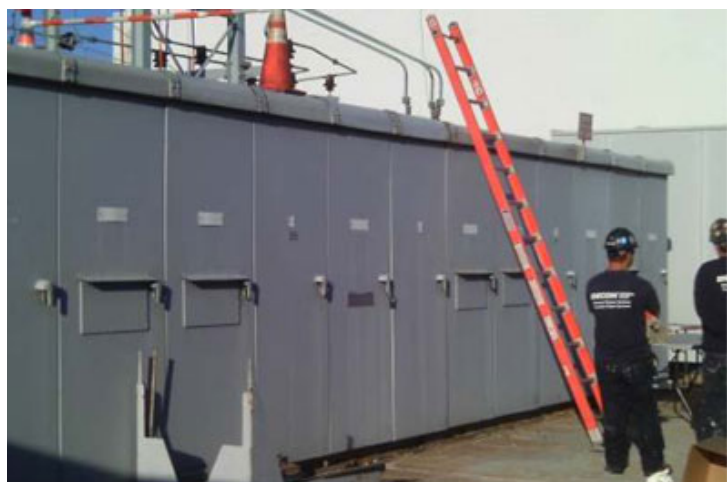
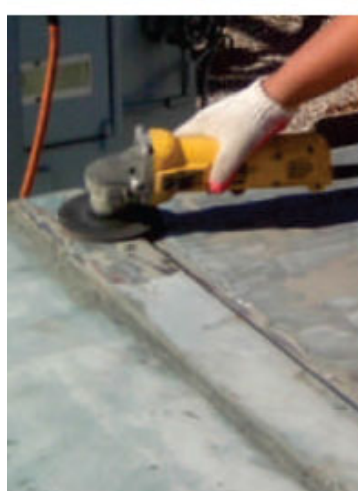
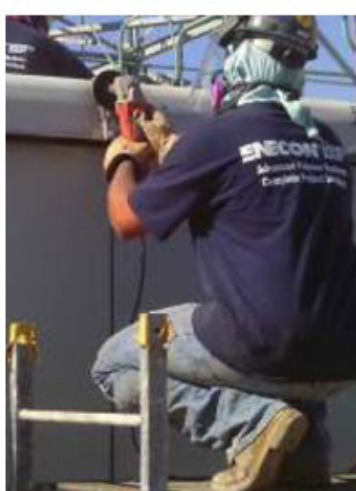
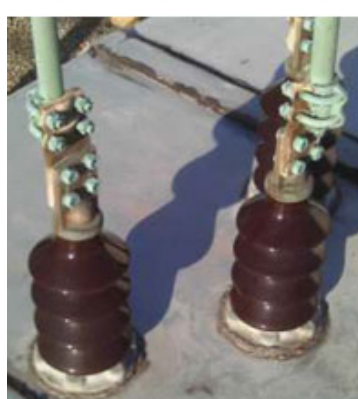
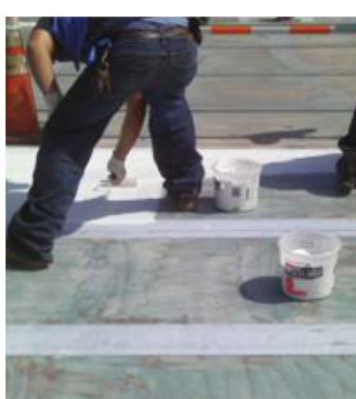
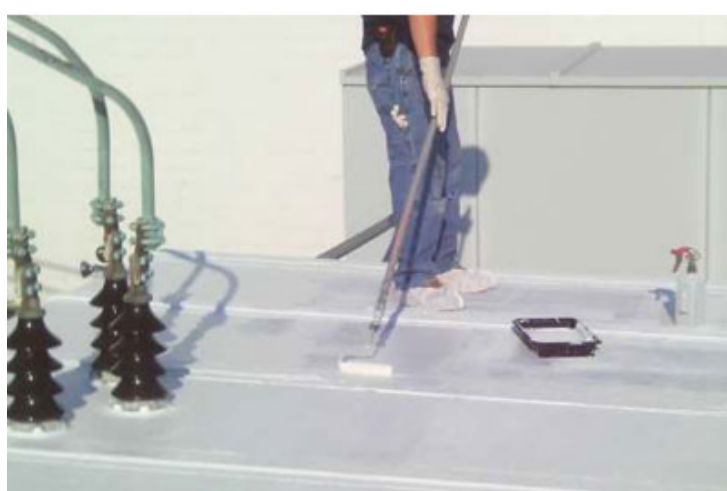
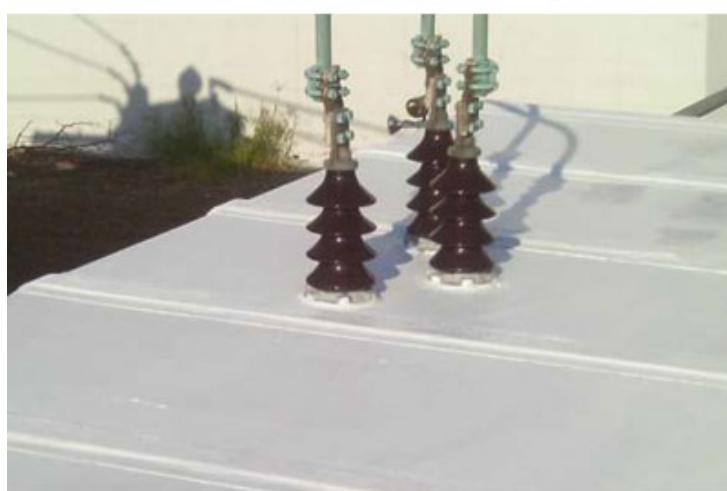
Problem: Aging switchgear cabinet roofs (constructed of galvanized sheet metal) were leaking at the seams and porcelain bushing penetrations.

Solution: After first removing the failing metal straps and rubber gaskets/seam covers, the entire roof was manually abraded. New 'coatable' roofing seam tape was applied to the open seams. ENESEAL CR was then applied as a 'primer' followed by two coats of ENESEAL HR.
