Enecon North East News
Oct. 2017 | Vol 9, Issue 11

CeramAlloy Used To Repair & Protect 35 Year Old Chiller

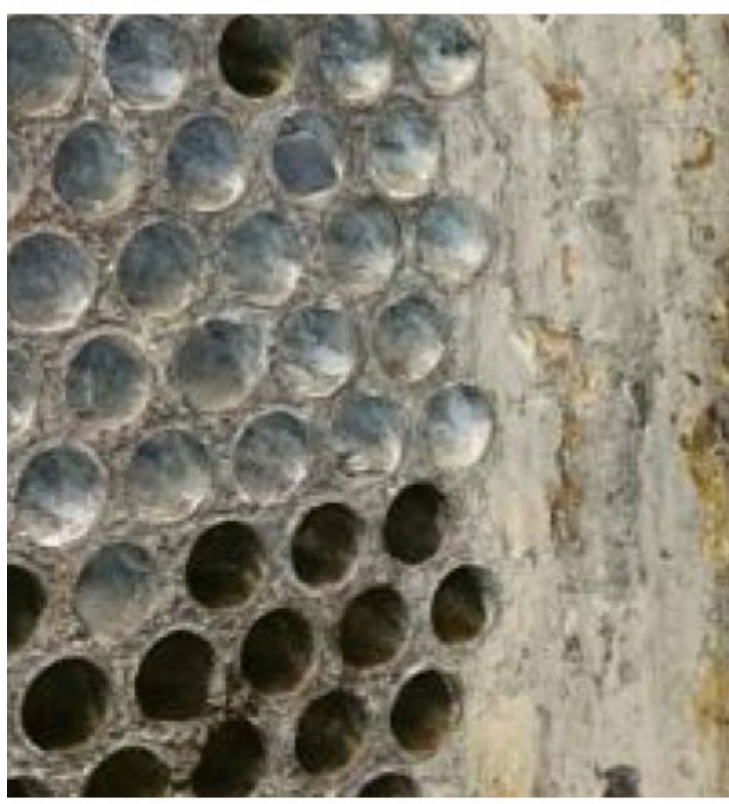
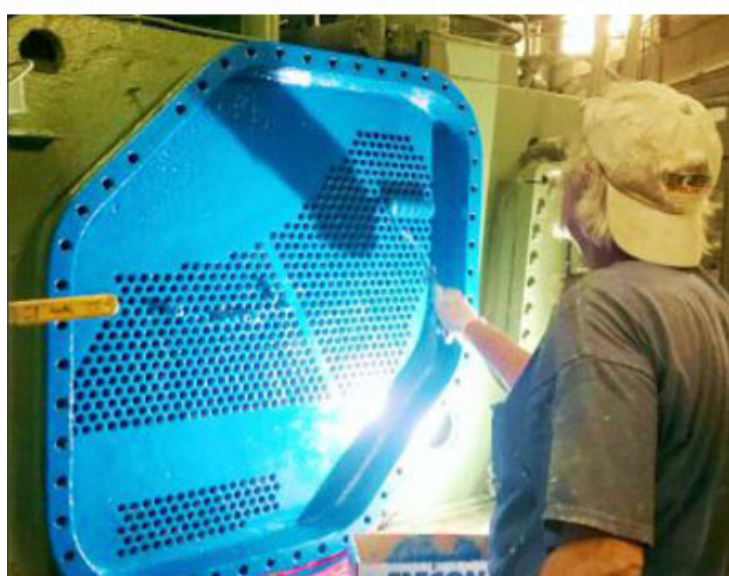
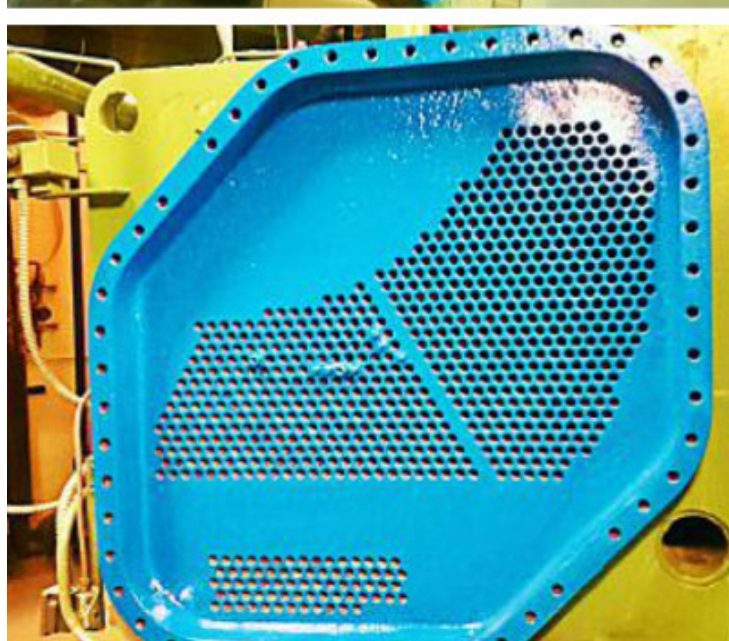
A Denver office building was dealing with a large 35 year old chiller that had begun to leak around the gasket. Upon inspection it was discovered that there were several causes of the leak.

Years of use of a daisy style gasket had exposed sections of the flange face to erosion and corrosion. The inside face of the box near the flange was eroded as well as a groove worn into the end cap.

After grit blasting, METALCLAD CeramAlloy CP+AC was used to rebuild the damaged areas. Two coats of CeramAlloy CL+AC were then applied to protect these components from future erosion corrosion damage.

ENECON was able to bring this huge 18 foot long, 35 year old unit back into service and deliver a solution designed to give them many years of additional service.
