Enecon North East News
Nov. 2017 | Vol 9. Issue 12

**University Building Leaks Stopped
With ENESEAL**

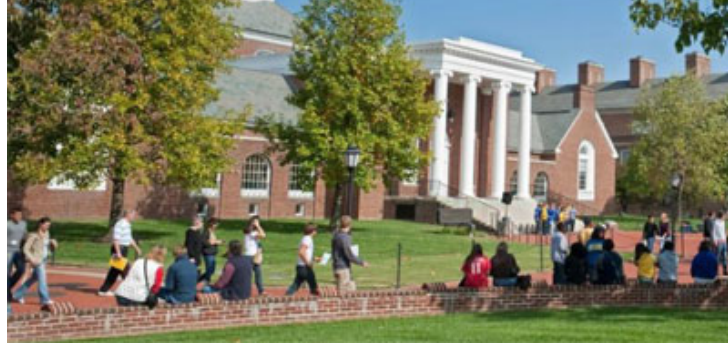
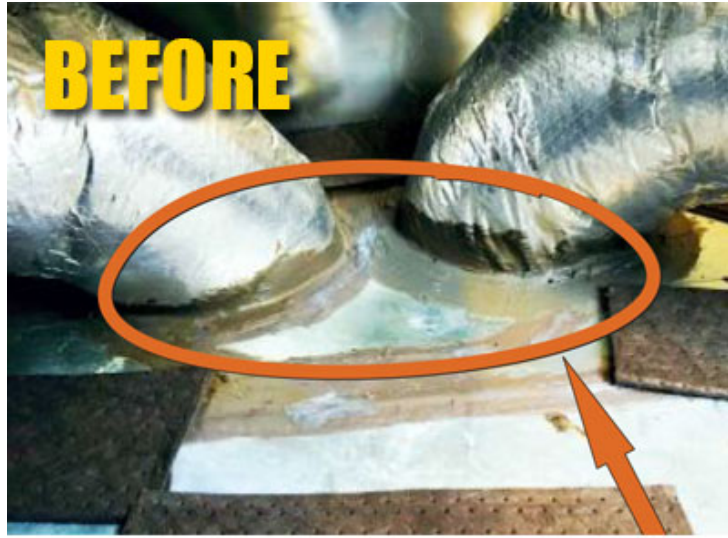
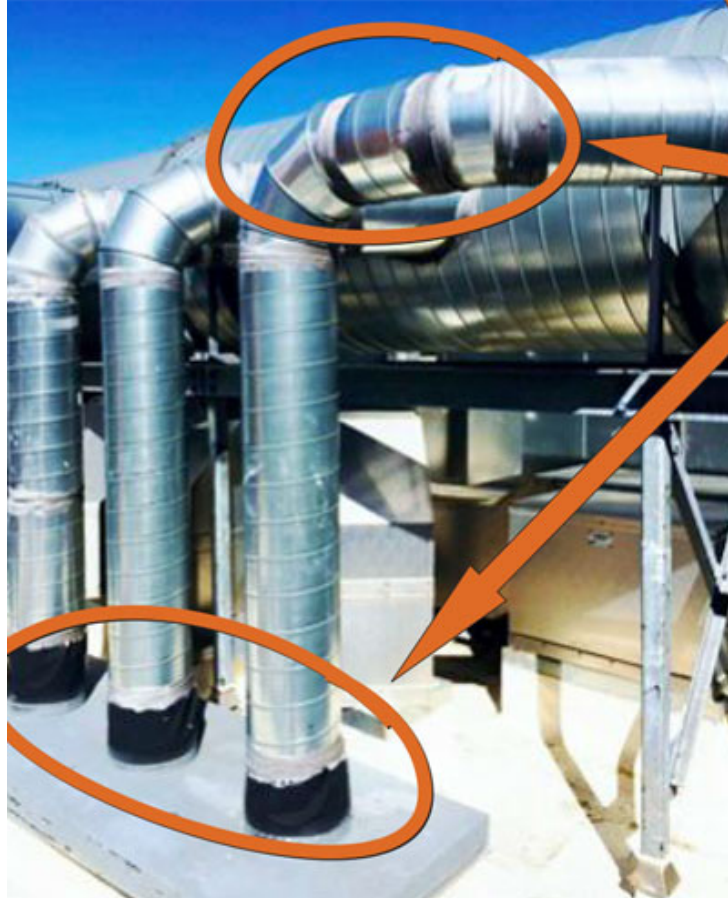
An area where these roof top air circulation pipes converge to enter a university building was vulnerable to leaks from rainwater. When this area leaked, water would drip down to laboratories below filled with expensive equipment.

The pipes are spiral wound stainless steel, so corrosion is not a problem, however rainwater was entering the pipes through the pipe-winding joints.

Earlier spot repairs circled in the before photos were not effective. The university maintenance team needed a better solution.

All the joints were sealed with Viscotaq sealing tape followed by two coats of ENESEAL CR.
