Enecon North East News  
Dec. 2017 | Vol 9, Issue 14

*ENECRETE & FLEXICLAD Protect  
New Clarifier At Canadian Iron Mill*

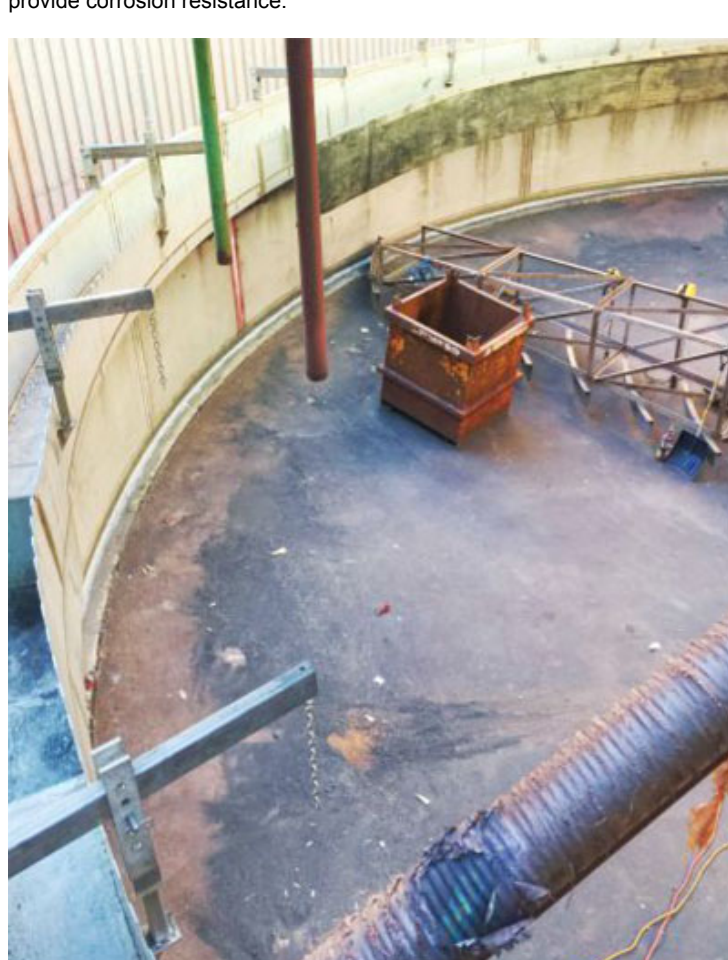
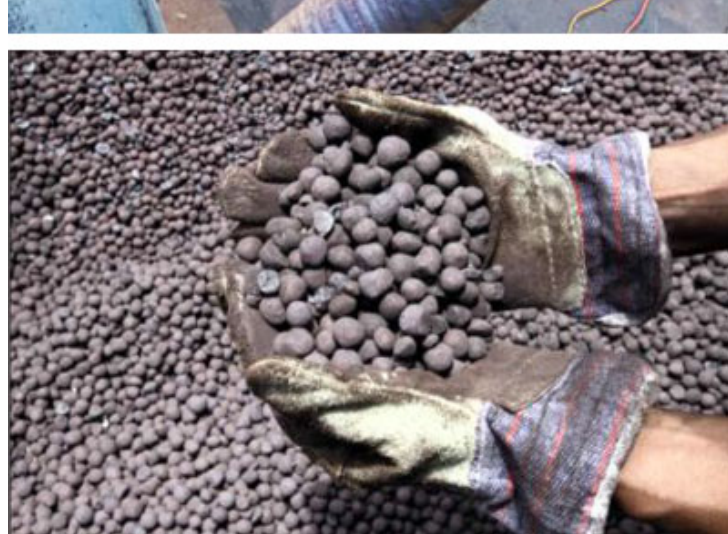
DuraQuartz application

After years of use and exposure to the elements, this tank at a pellet manufacturing plant in Canada needed to be replaced. The old tank was removed and ENECRETE DuraQuartz was used to repair the concrete base before the new tank was installed. Because this tank was situated between two buildings a 250 ton crane was used to lower the new tank sections into place.

DuraQuartz was used again to fill in any gaps where the tank met the uneven, old concrete base. The new tank and base were then joined and held in place using a bolted steel flange. The joint between the flange and the concrete base inside and outside of the tank were then sealed with FLEXICLAD PC. This will allow for expansion and contraction where these two dissimilar materials meet.

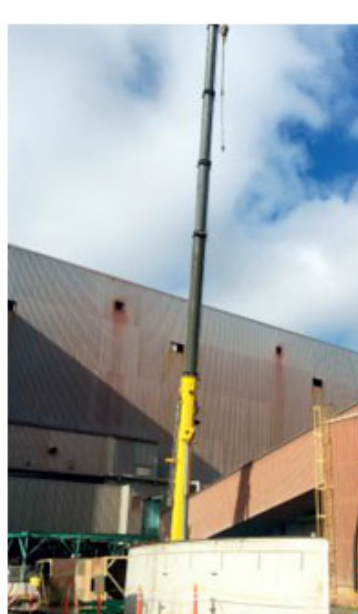
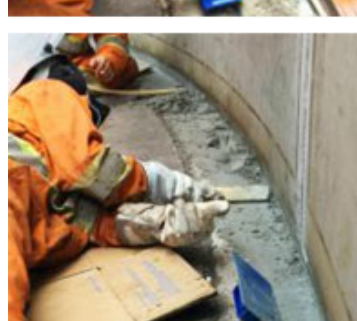
Then FLEXICLAD PC

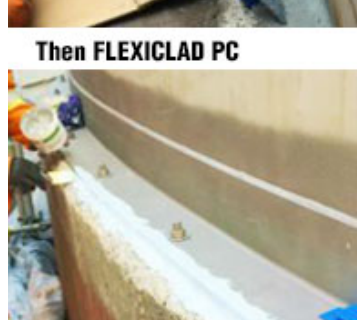
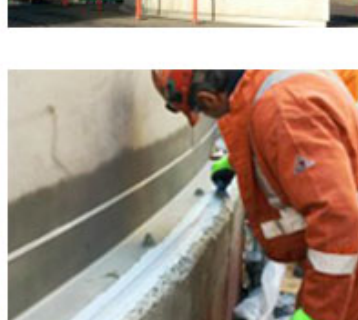
Final application of ENESEAL CR

Lastly, ENESEAL CR was finally applied to the outer flange area to provide corrosion resistance.
