Enecon North East News
 Sept. 2018 | Vol 10. Issue 8

Power Plant Salvages One Million Gallon Tank With DurAlloy, CHEMCLAD & FLEXICLAD

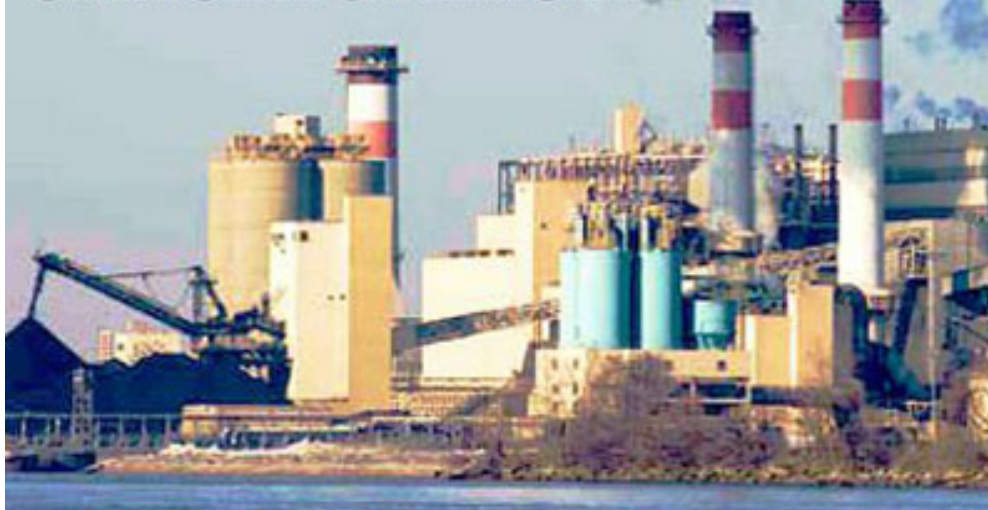
Located at a Pennsylvania power plant, this sixty-five foot diameter, one million gallon tank was sitting dormant for many years and had severely corroded.

There were holes in the tank walls and piping as well as leaks through the floor / wall seams. The lack of any regular maintenance had rendered this tank unusable.

The existing coating was grit blasted off the tank walls eight feet high and all of the failed caulk from the floor / wall seam was removed.

The holes were repaired using METALCLAD DurAlloy. The walls then received two coats of CHEMCLAD SC. Once the CHEMCLAD was cured the entire floor / wall seam was sealed with FLEXICLAD PC.

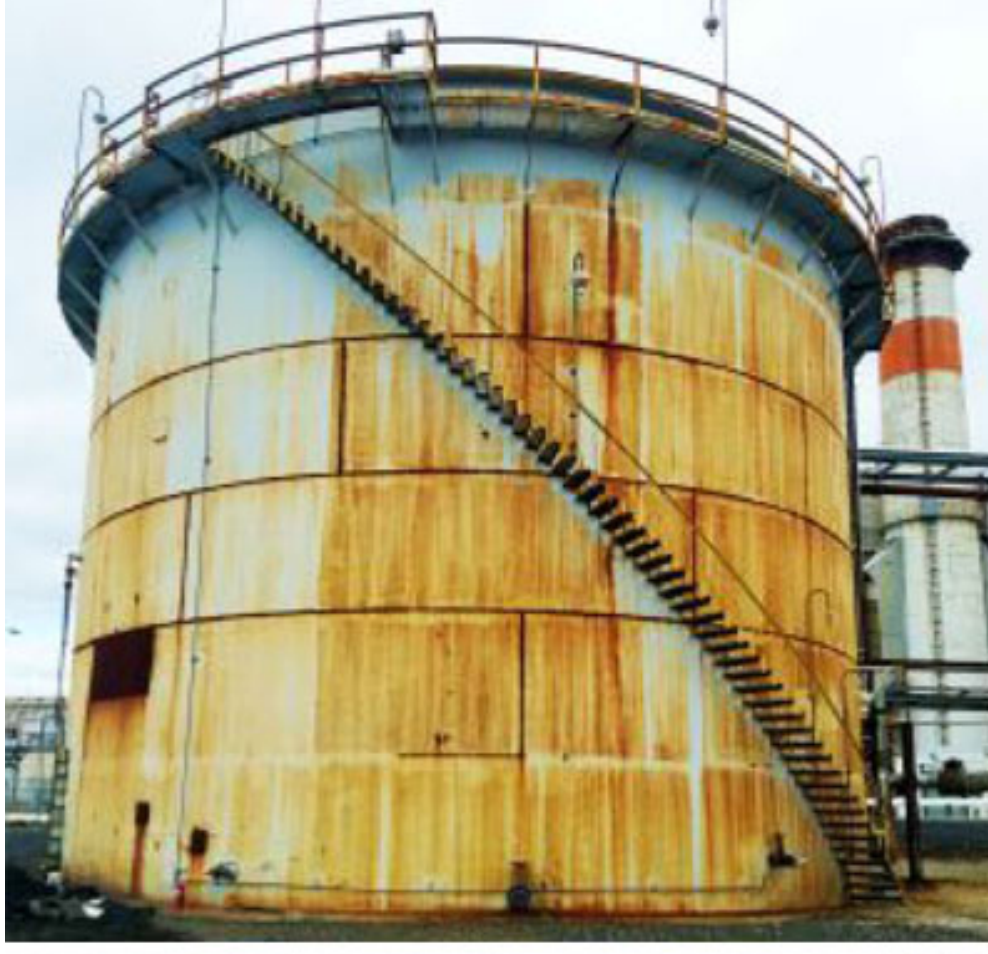
Holes in tank wall
