Enecon North East News
Feb. 2019 | Vol 11. Issue 2

CeramAlloy Used To Repair & Protect 35 Year Old Chiller

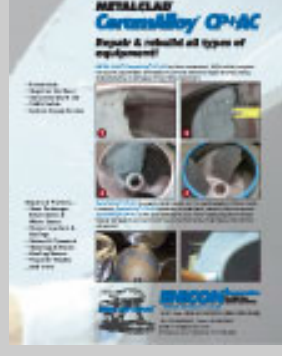
CERAMALLOY CP+AC

Years of use of a daisy style gasket had exposed sections of the flange face to erosion and corrosion. The inside face of the box near the flange was eroded as well as a groove worn into the end cap.

After grit blasting, METALCLAD CeramAlloy CP+AC was used to rebuild the damaged areas. Two coats of CeramAlloy CL+AC were then applied to protect these components from future erosion corrosion damage.

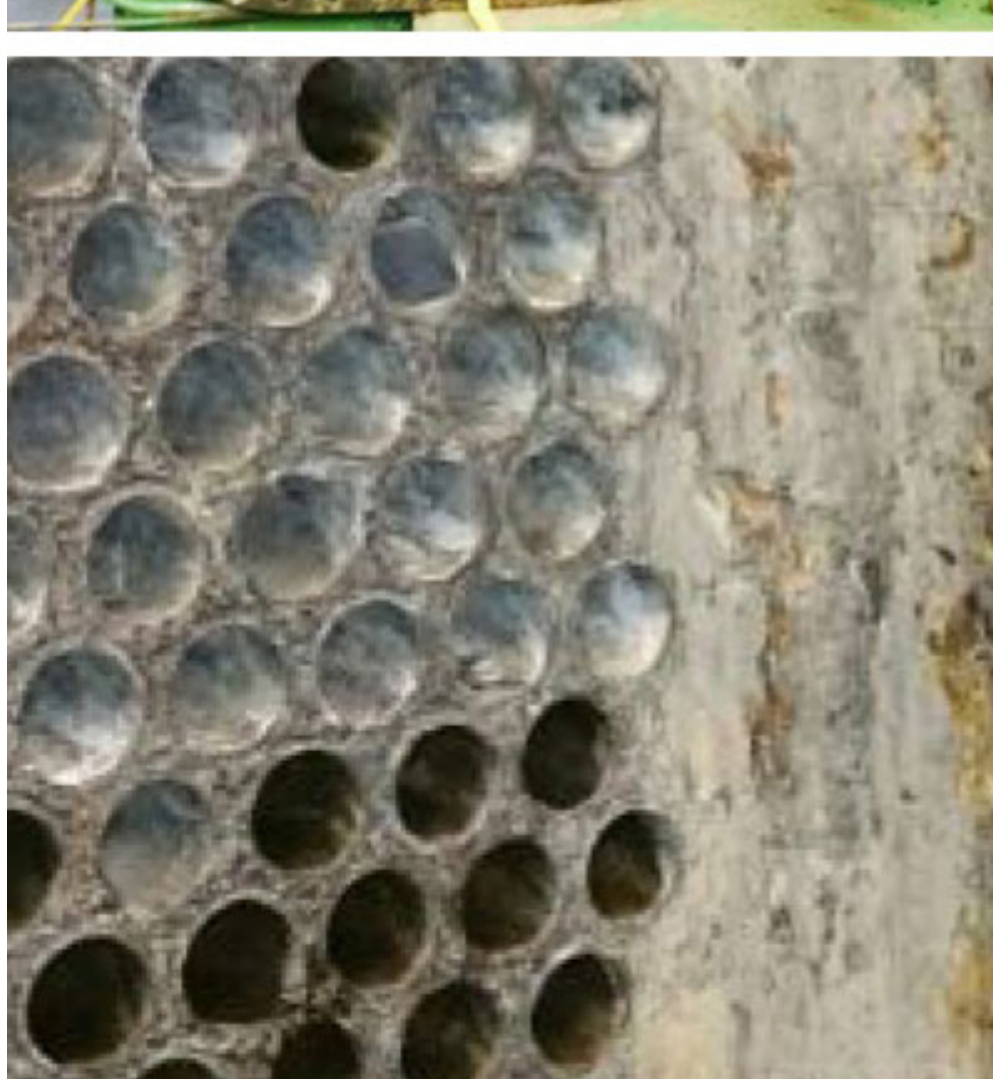
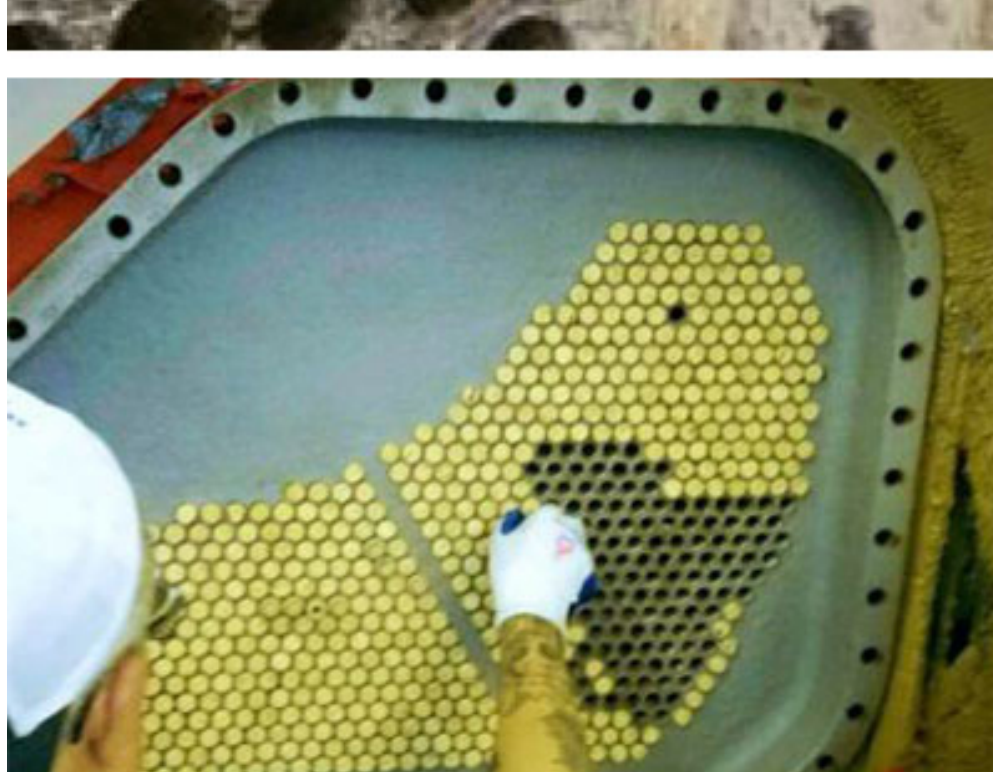
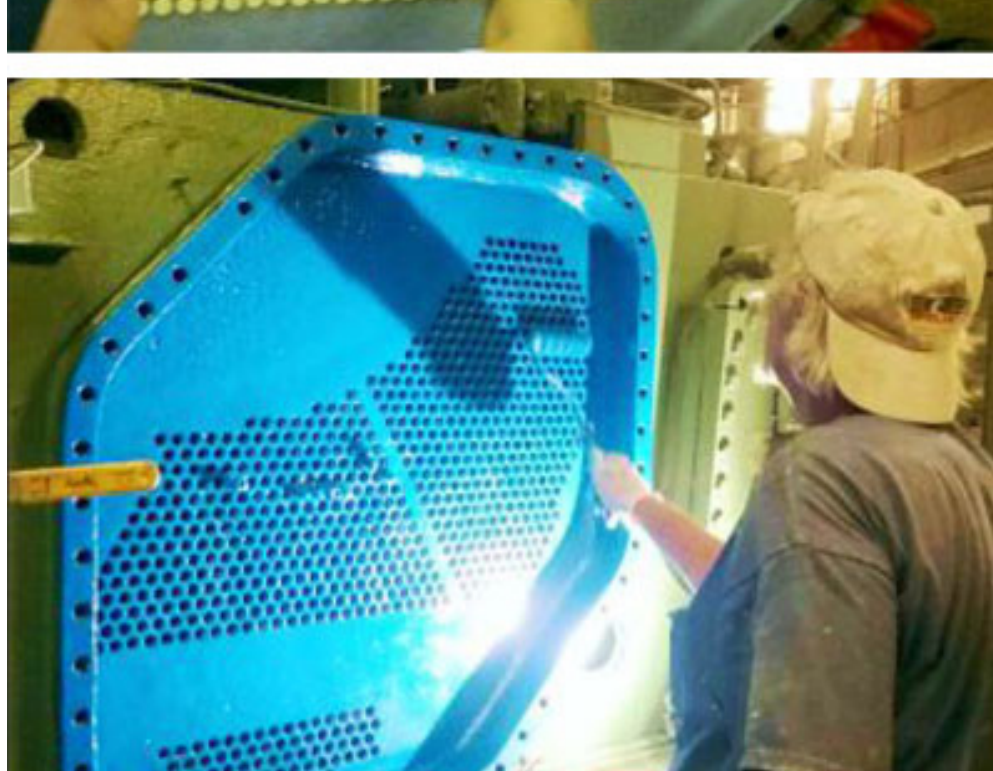
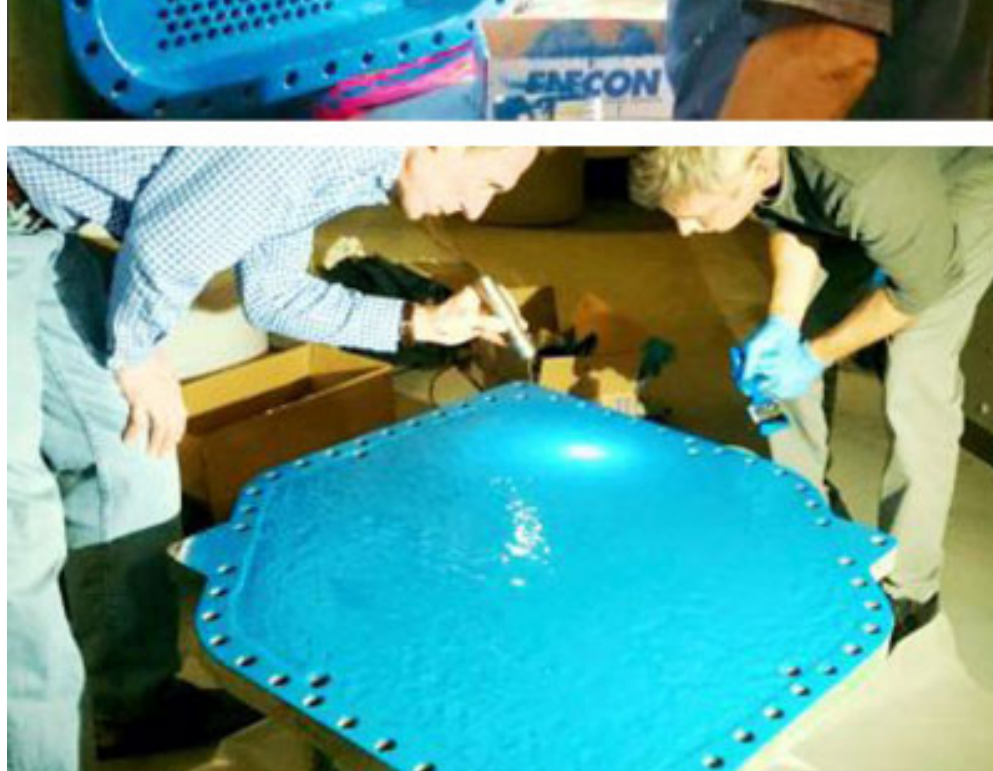
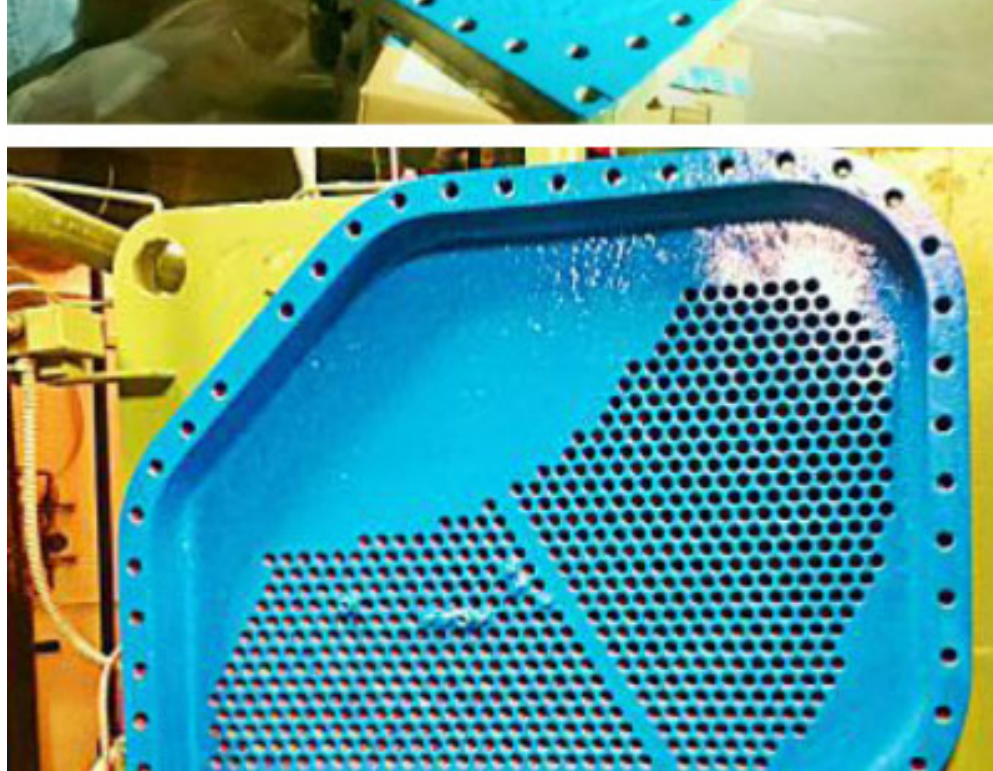
A Denver office building was dealing with a large, 35 year old chiller that had begun to leak around the gasket. Upon inspection it was discovered that there were several causes of the leak.

ENECON was able to bring this huge 18 foot long, 35 year old unit back into service and deliver a solution designed to give them many years of additional service.
