Enecon North East News
Feb. 2016 | Vol 8, Issue 1

A Utility 30" Salt Water Line Repaired Using Carbon Fiber

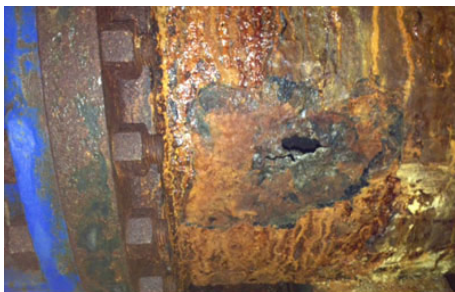
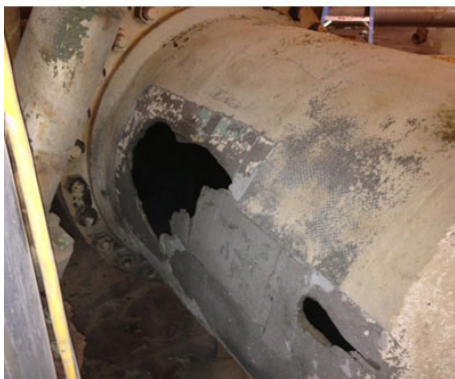
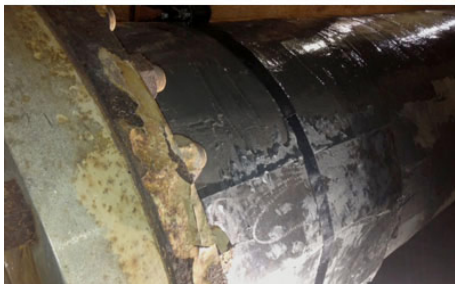
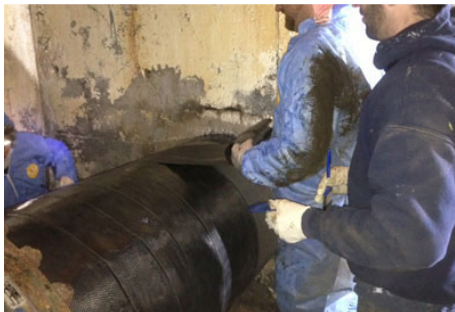
At a Northeast Power plant has a 30" main salt water inlet line that ruptured requiring an emergency outage and shutdown. The facility turned to the **ENECON** emergency response team to provide a proposal for the preparation and application of the **DuraWrap Carbon Fiber encapsulation system** that would externally reinforce the 30 inch diameter salt water service line. The facility was concerned with the condition of the pipe, and if it failed it could force a long shut down to replace the pipe.

ENECON Northeast APS abrasive blasted the external surfaces of the pipe to achieve at minimum an SSPC-SP6 (commercial blast) and applied the **ENECON DuraWrap carbon fiber reinforced pipe wrap system** on approximately 40 SF of the pipe area.

The actual holed area was repaired using a steel plate bonded over the leak location using **ENECON DurAlloy** as a "cold weld" process. This was followed by the application of **ENECON DuraWrap, carbon fiber reinforced pipe wrap system** applied for several feet on either side of the leak location for a total application of approximately 4 linear feet. Heat was applied for 24 hours and the salt water line was returned to service. The final result was a significant saving to the facility and they were able to start operation again within 48 hours.
