ENECON repairs condenser water pipe sections and adds structural reinforcement with the ENECON DuraWrap Carbon Fiber wrap system.

FEBRUARY 2010 | VOLUME 2, ISSUE 3

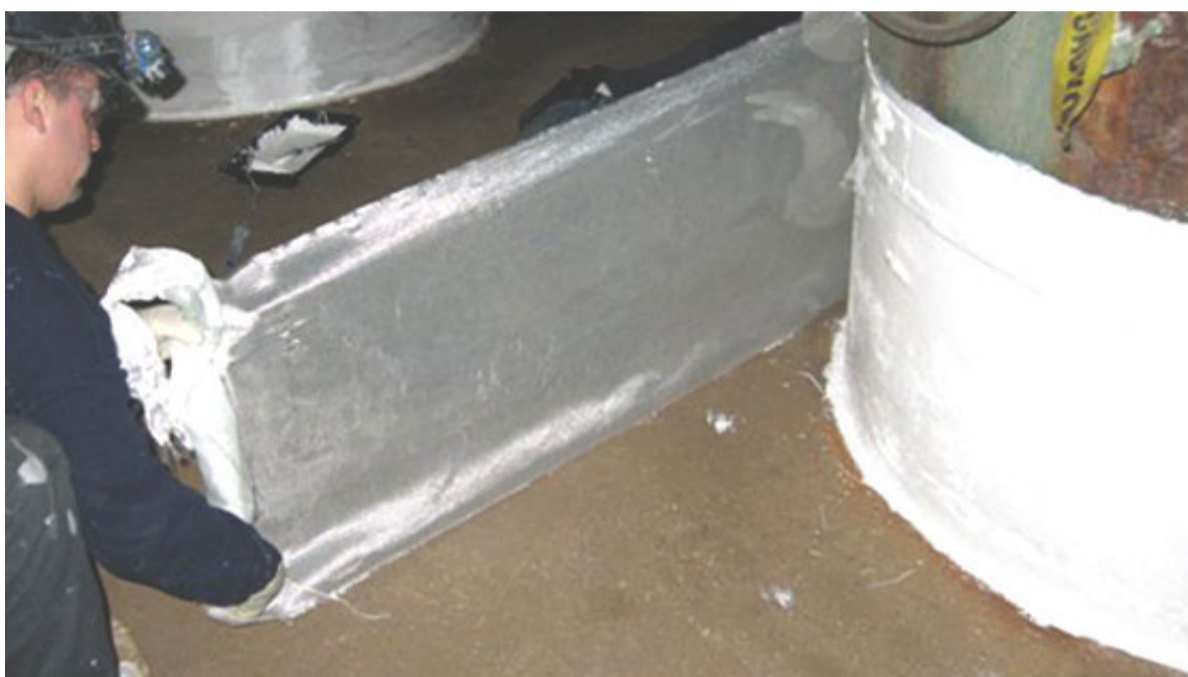
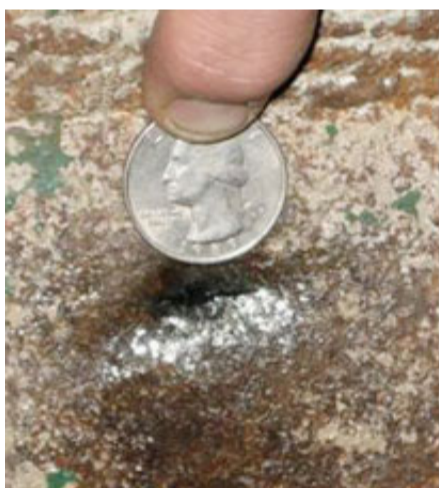
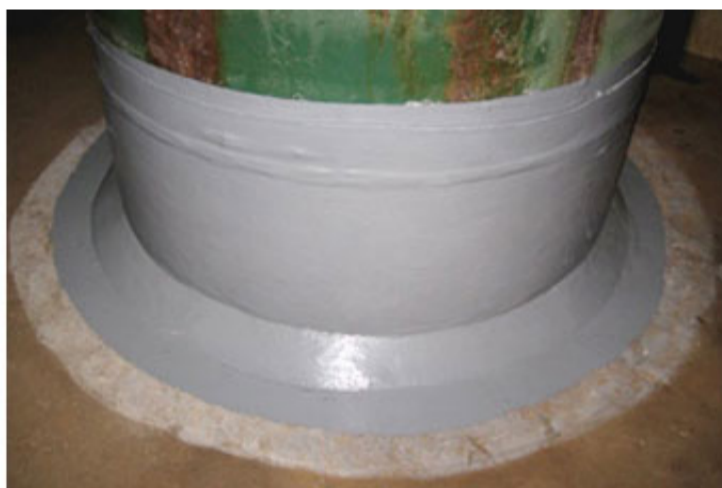
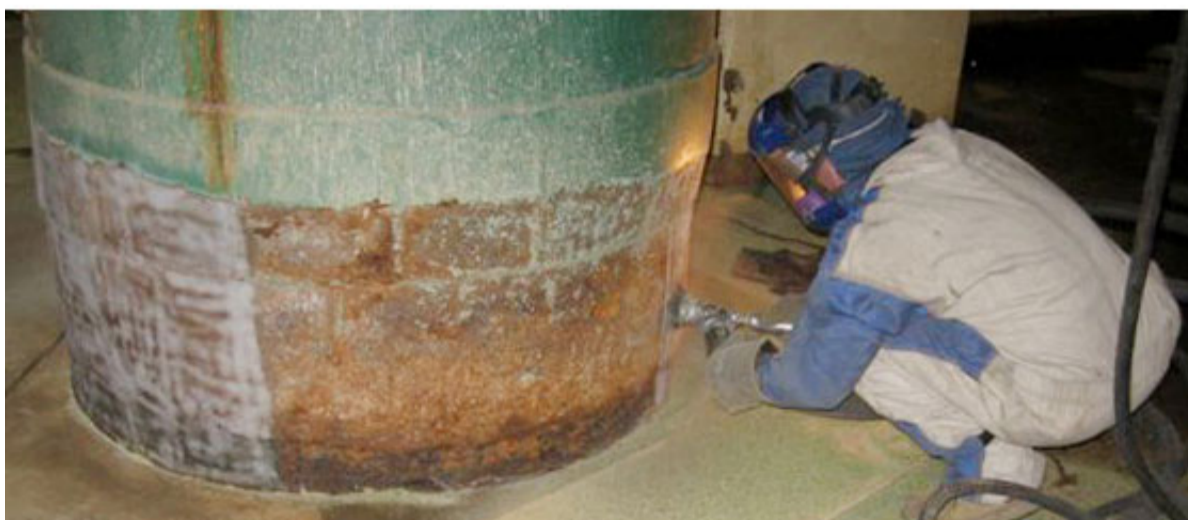
ENECON North East recently completed the external preparation and fiber reinforcement of four 56 " OD condenser water discharge pipe sections located at a Northeast Power Plant. The section of the pipes were wrapped with the ENECON DuraWrap synthetic fiber reinforcing system from the concrete deck up approximately four feet. The project included the preparation, reinforcement and coating of external pipe surfaces including the installation of a Polymeric Mortar Wedge at the pipe to floor interface to prevent standing water degrading the external surface of the pipe.
