## Enecon North East News

Feb 2014 | Vol 6. Issue 3

## REPAIR OF WATER MAIN USING ENECON DURAWRAP CARBON FIBER

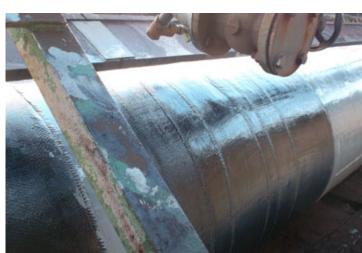
This pipe at a steel mill was constantly exposed to hypo-chlorite fall out from a nearby cooling tower as well as being in contact with sludge from the mill. Although previously wrapped in a 'tape-like' product, the pipe was showing signs of advanced corrosion. The tape system was entrapping moisture, accelerating the corrosion, and needed to be removed.

ENECON CeramAlloy CP (Ceramic Paste) was used to repair heavily corroded areas prior to being repaired using ENECON DuraWrap Carbon Fiber.

The proposed repair method required abrasive blasting to remove all traces of corrosion and old protective wrap.

DuraWrap has a tensile strength of 123,600 PSI and bonds to steel at a rate of 3,500 PSI. Full cure is achieved within 24-48 hours.

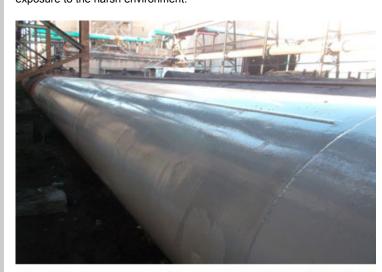
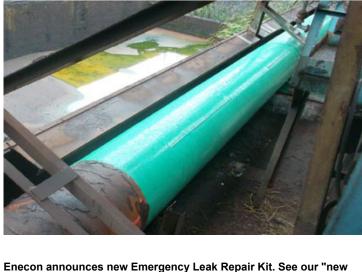
The pipe was then protected with ENECON ChemClad SC to guard from exposure to the harsh environment.
