Enecon North East News  
Sept 2014 | Vol 6. Issue 8

**Detention Center Stops Cooling Tower Corrosion with ENESEAL CR**

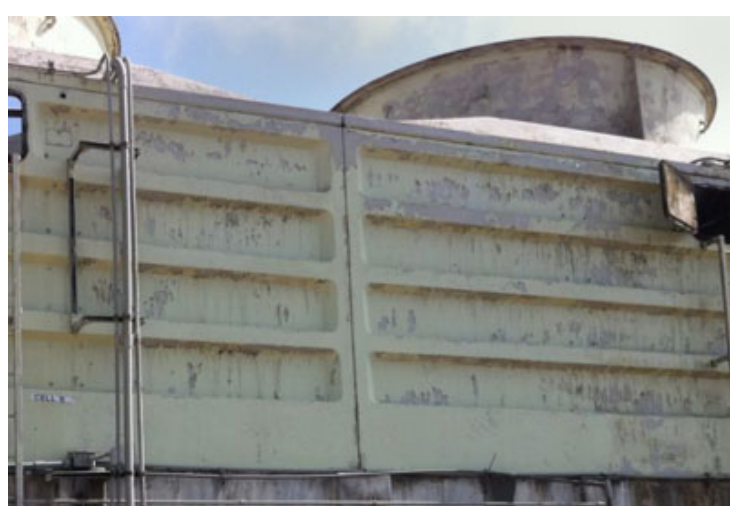
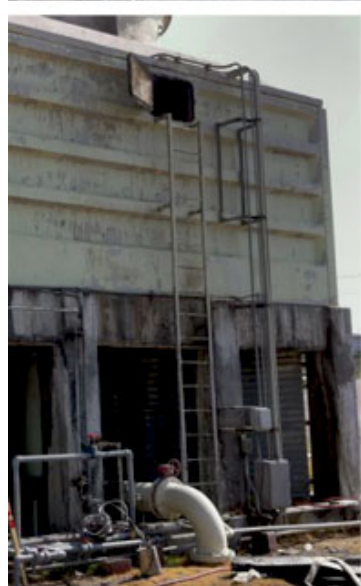
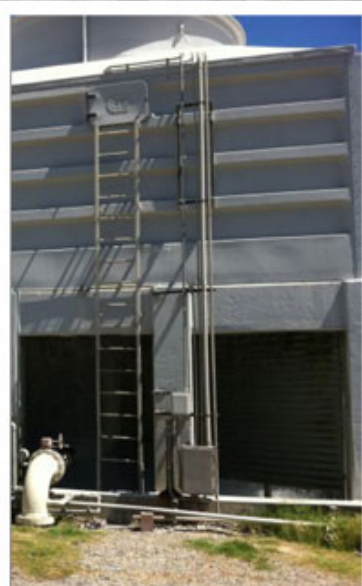
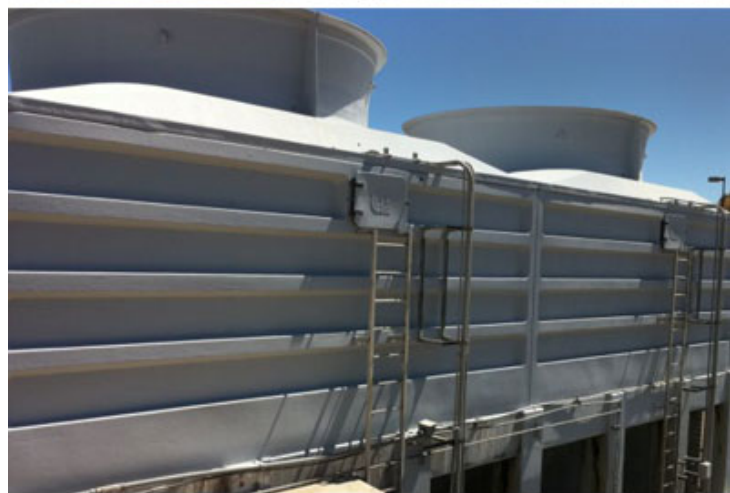
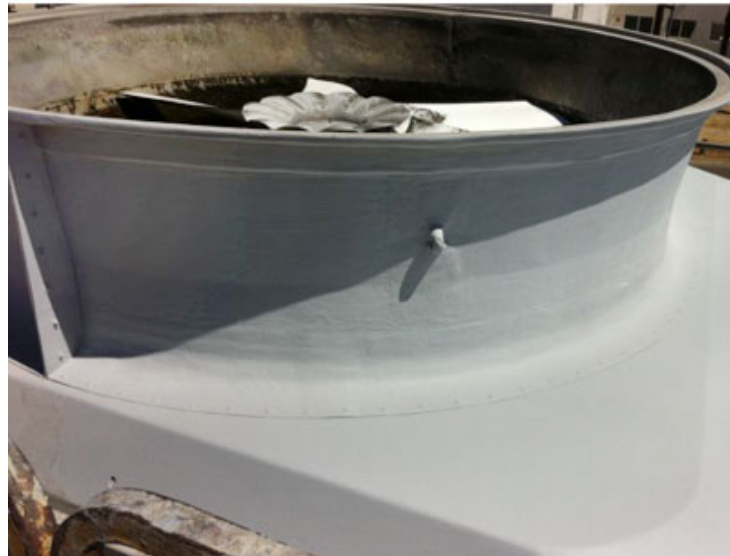
**Problem:** Cogen plant cooling tower was corroding at an accelerated rate.

Cooling Towers are subject to constant damage due to weather including rain, snow and freezing. Corrosion is a constant problem for the facility engineer. Replacement of the mechanical equipment is often not an option.

**Solution:** After surface prep that consisted of power washing and grit blasting, ENESEAL CR was applied to provide long term corrosion resistance.

The Engineers on this project needed to find a solution that would protect the equipment from further damage and could be applied by their in-house personnel. ENECON EneSeal CR is an acrylic coating system that contains a rust inhibitor which will protect the steel surfaces from further deterioration. EneSeal can be applied with a brush or rollers and clean-up is with water rather than solvents. This coating proved to be the best choice for the facility and their personnel.
