Enecon North East News
Oct. 2015 | Vol 7. Issue 8

Northeastern U.S. Power Company Protects Switchgear Cabinet Roofs with ENESEAL

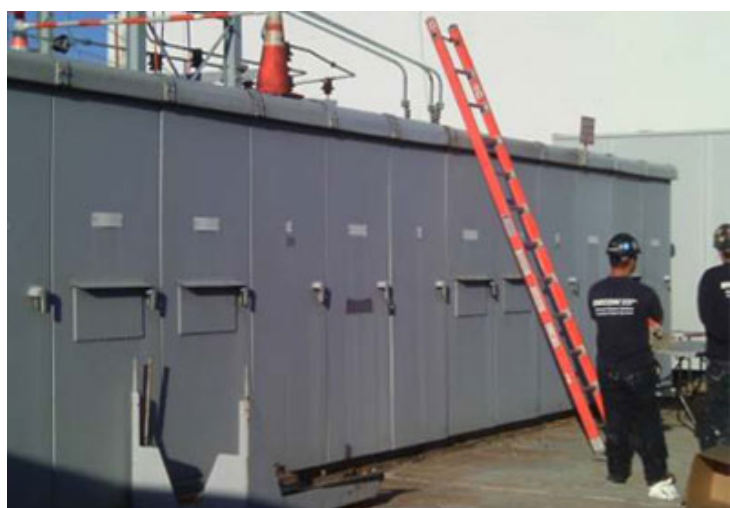
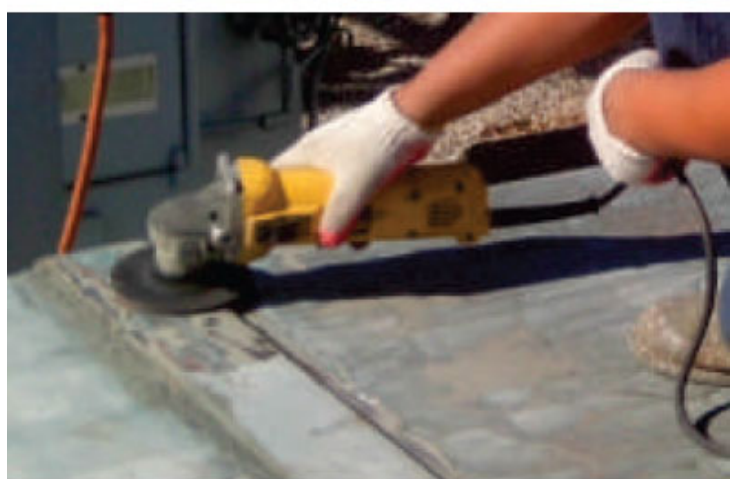
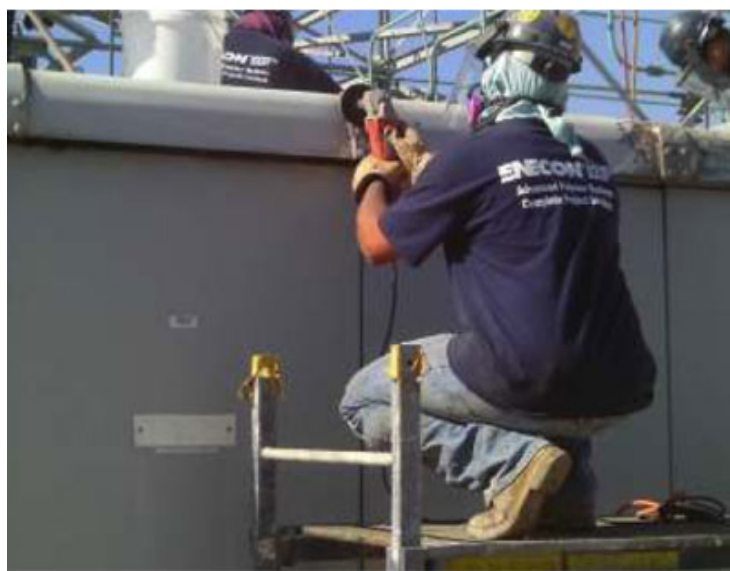
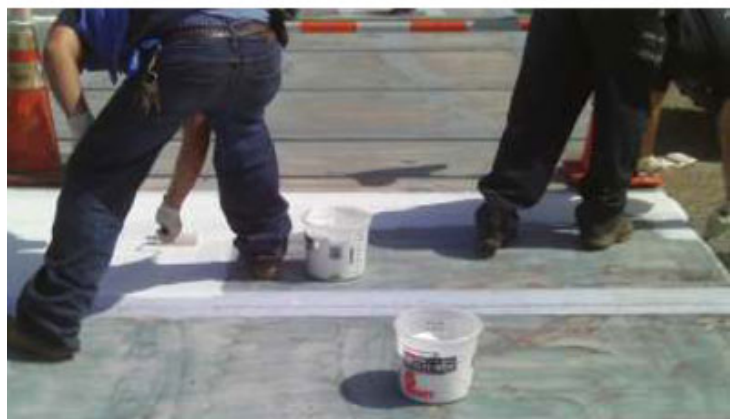
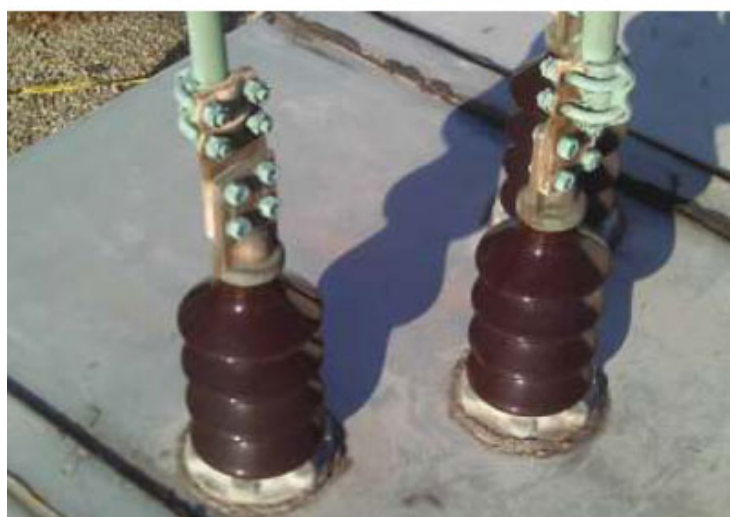
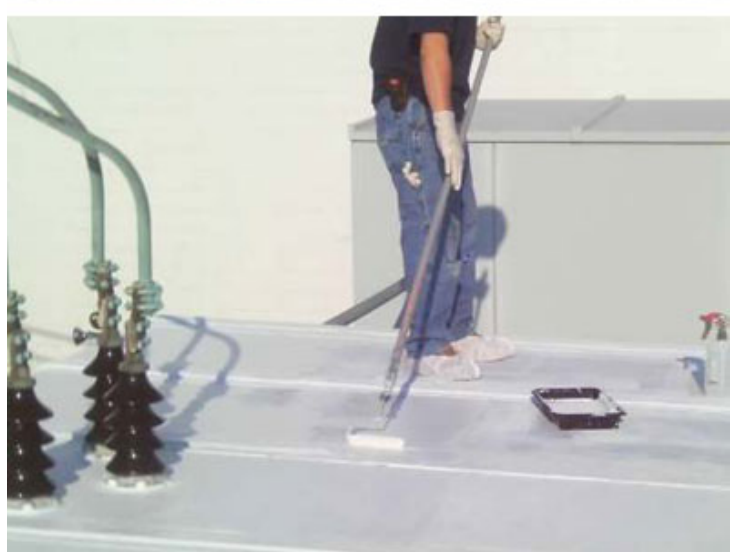
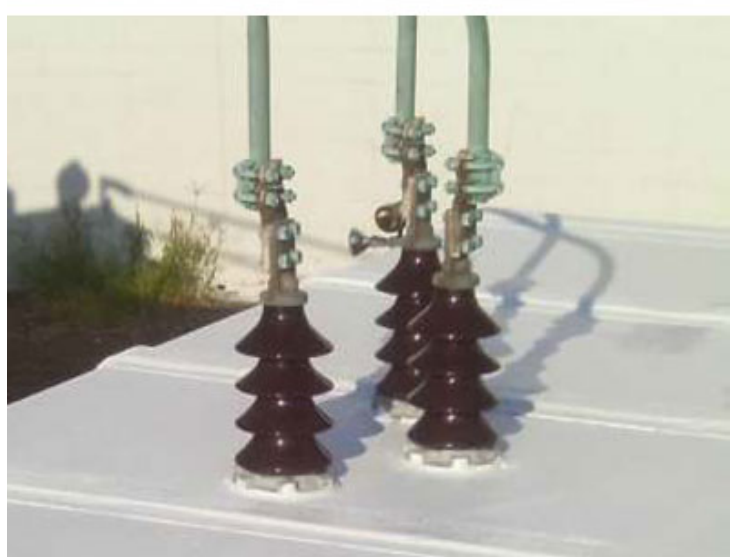
Problem: Aging switchgear cabinet roofs (constructed of galvanized sheet metal) were leaking at the seams and porcelain bushing penetrations.

Solution: After first removing the failing metal straps and rubber gaskets/seam covers, the entire roof was manually abraded. New 'coatable' roofing seam tape was applied to the open seams. ENESEAL CR was then applied as a 'primer' followed by two coats of ENESEAL HR.

Time to Completion: Each switchgear cabinet takes about 3 days to complete. Numerous cabinets have been completed at various locations for this power company.
