Enecon North East News
 Mar. 2016 | Vol 8. Issue 2

Deteriorating Containment Areas, Pump Bases, and Sumps in Need of Repair at Chemical Company

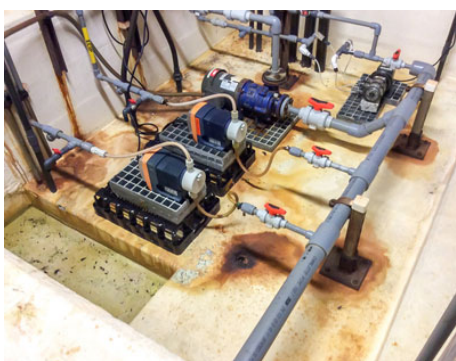
When previous coatings had failed numerous times, a prestigious U.S. chemical company called on ENECON to protect its badly deteriorating containment areas, pump bases and sumps.

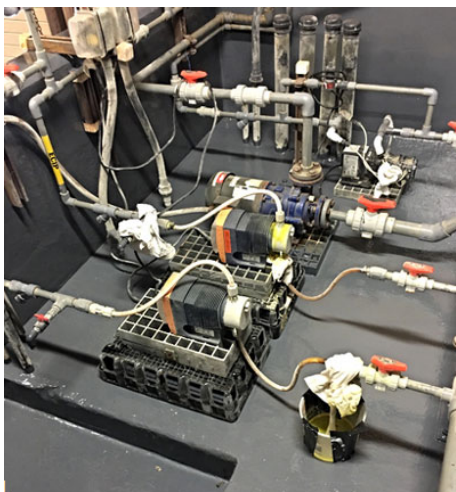
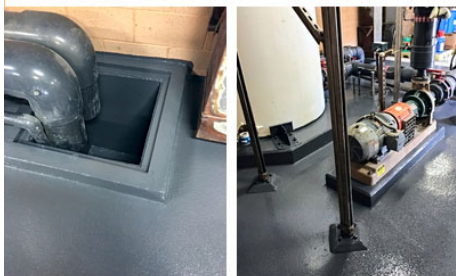
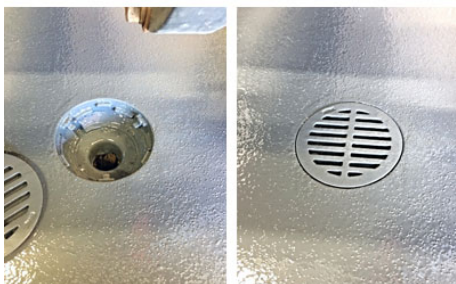
ENECON prides itself on these types of difficult industrial solutions because we not only have the right products, but we also have the know-how and expertise regarding surface prep, cure times in between coats, and all of the small details that go into a project like this for it to be not only effective, but also properly done the first time. This turnkey project was completed in less than two weeks with no plant down time. In addition to helping the customer comply with the local chemical containment area codes, this application will provide unsurpassed chemical attack protection for decades to come.
