Enecon North East News
May, 2016 | Vol 8, Issue 3

DuraWrap Repairs Cooling Tower Supply Line at Power Plant

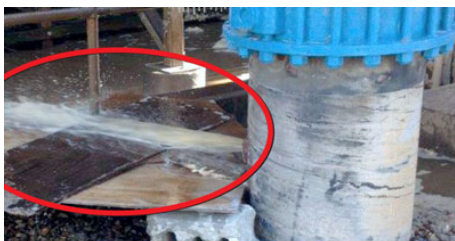
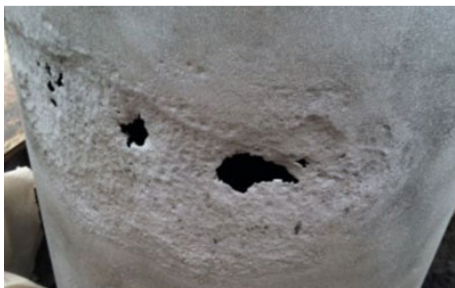
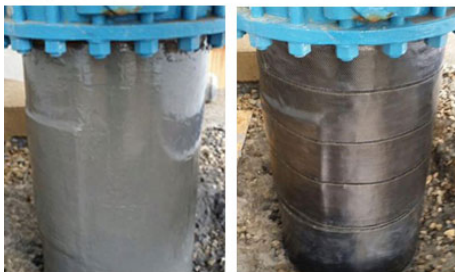
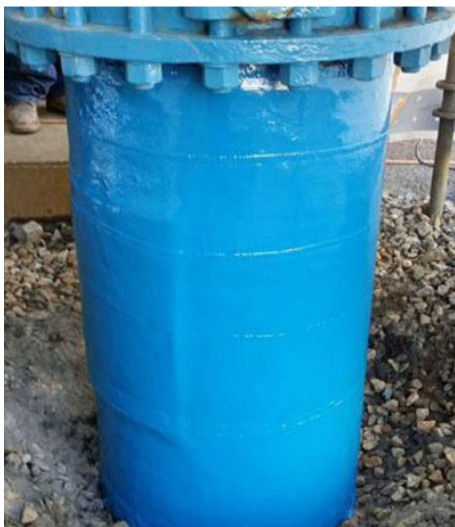
This 24 inch diameter intake pipe, located at a U.S. Power Plant, was leaking above the ground at about a foot below the disc valve. The plant's maintenance engineers needed a proven, reliable, economical solution to this problem.

The local ENECON Distributor was called in to develop a solution. First the exterior surface of the pipe was 'bristle blasted' to promote maximum adhesion by removing all existing failed coatings and corrosion.

Once the preparation was completed, a 12 x 12 x 1/8 inch thick curved steel plate was prepared and 'cold welded' over the holed area of the pipe using ENECON's DurAlloy.

That was followed by the application of two layers of the DuraWrap Carbon= Fiber Pipe Wrap System. CeramAlloy CL+AC was then applied to the entire area as a final layer.
