Enecon North East News
June 2016 | Vol 8. Issue 5

Deteriorating Containment Areas, Pump Bases & Sumps Repaired at Chemical Company

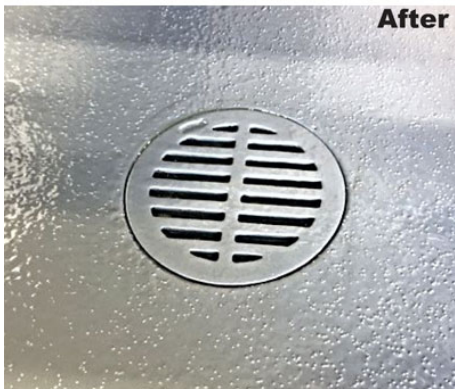
After

When previous coatings had failed numerous times, a chemical company called on ENECON to protect its badly deteriorating containment areas, pump bases and sumps.

The surfaces were first prepared by removing the old and delaminated coatings. All surfaces were later primed with ENECRETE DuraFill followed by two top coats of CHEMCLAD XC for unrivaled chemical attack protection.
