Enecon North East News
Nov. 2016 | Vol 8, Issue 9

Midwestern Chemical Processing Plant Uses ENECRETE, ENECLAD & CHEMCLAD To Repair & Protect Concrete Tank Base

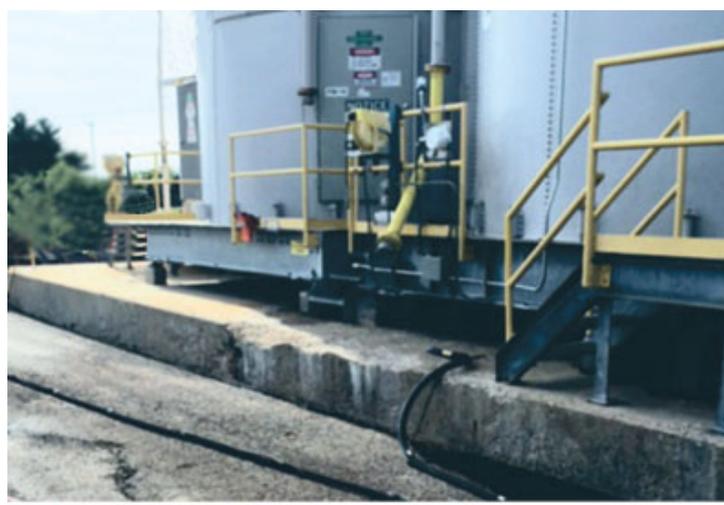
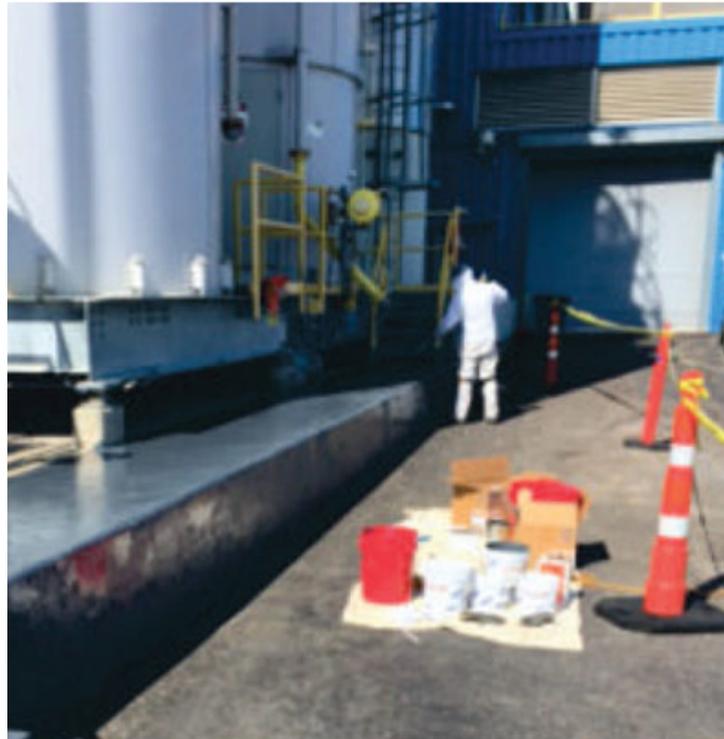
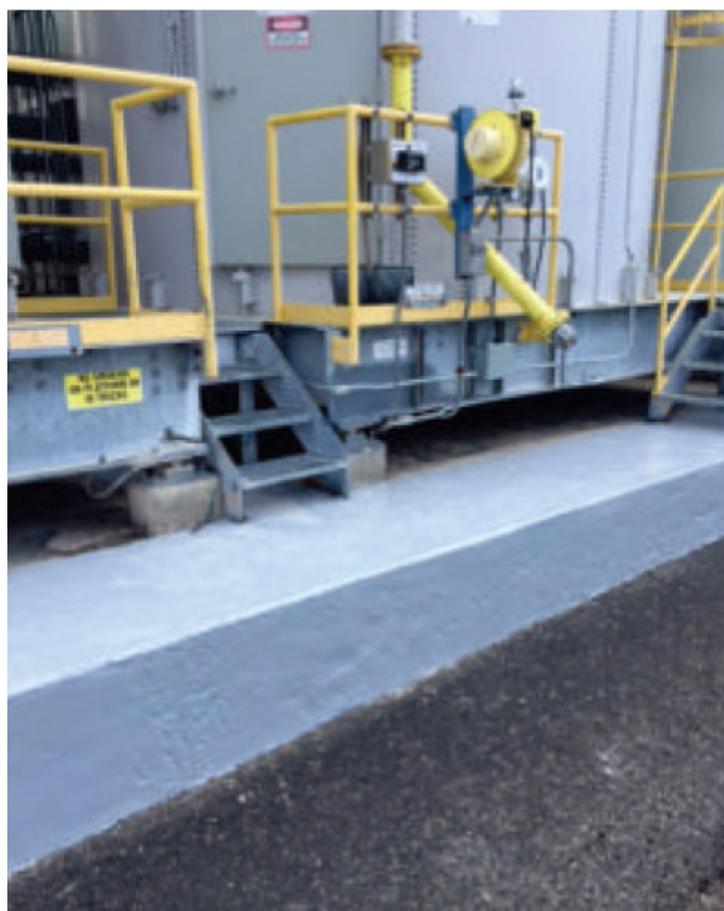
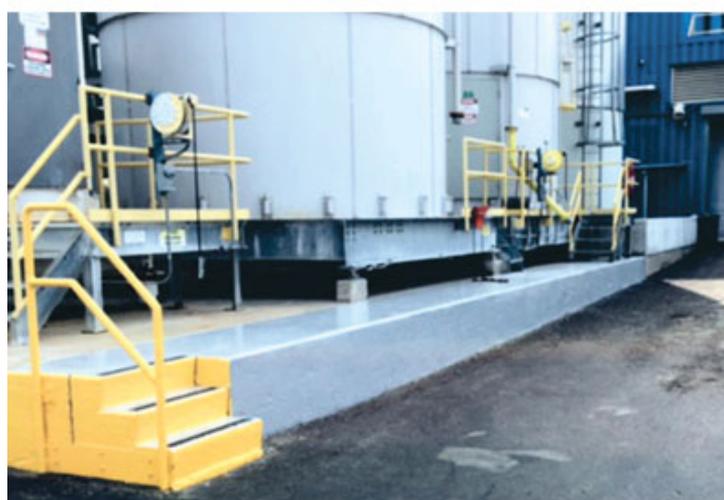
A concrete pad used as a base for six large storage tanks at a midwestern U.S. chemical processing plant was eroding from chemical attack and impact.

After pressure washing as well as vapor blasting to clean and remove contaminants, it was discovered that several sections had significant concrete loss. Vertical repairs were made with DuraQuartz LW whereas deeper damaged areas were repaired with DuraFill and a mixture of locally sourced pea-gravel and quartz sand.

The entire surface was then coated with a thin layer of ENECLAD SPS to level the area.

Finally, two coats of CHEMCLAD SC were applied. The stairs and railings were also coated with CHEMCLAD SC in safety yellow with the addition of aggregate back-rolled on the stair treads to provide slip-resistance.
