Enecon North East News  
 Jan. 2017 | Vol 9, Issue 1

## Chemical Company Repairs & Protects Concrete Storage Tank

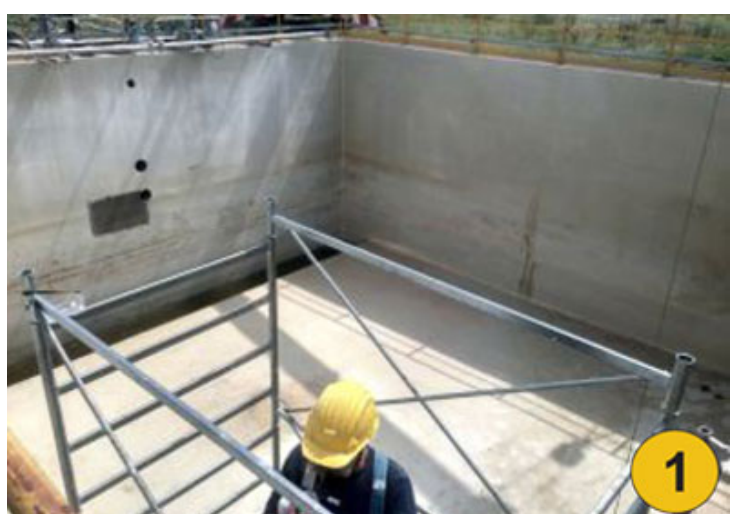
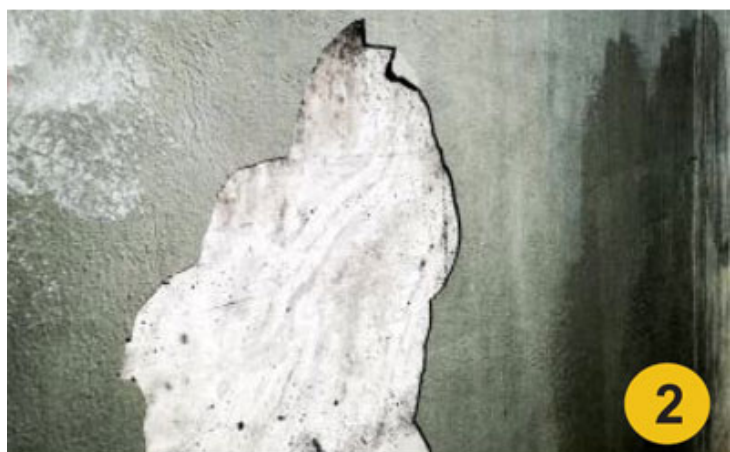
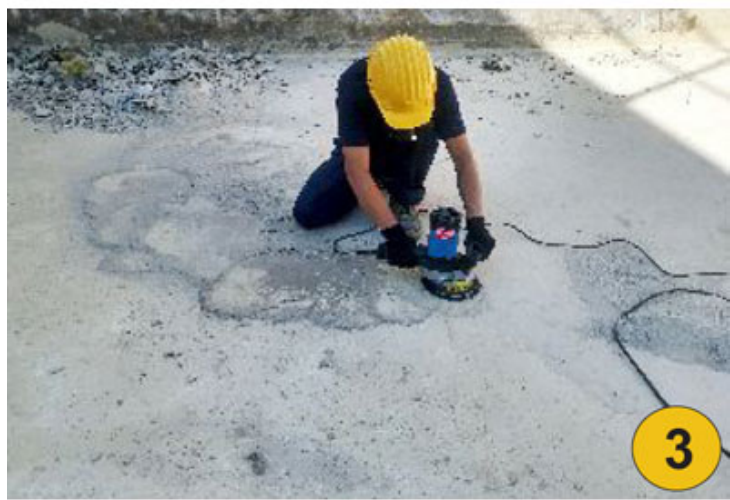
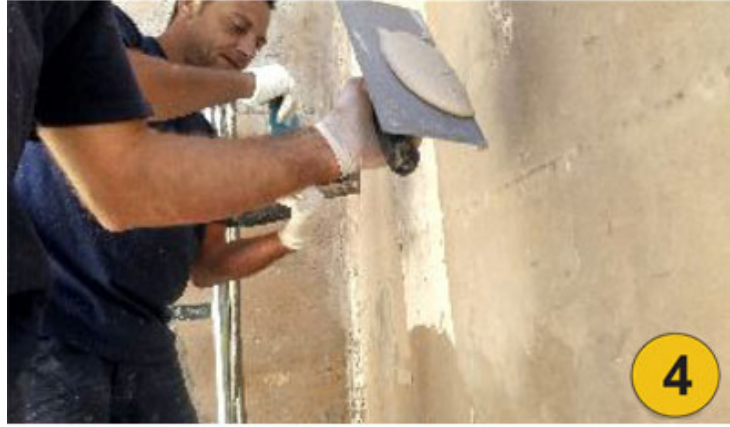
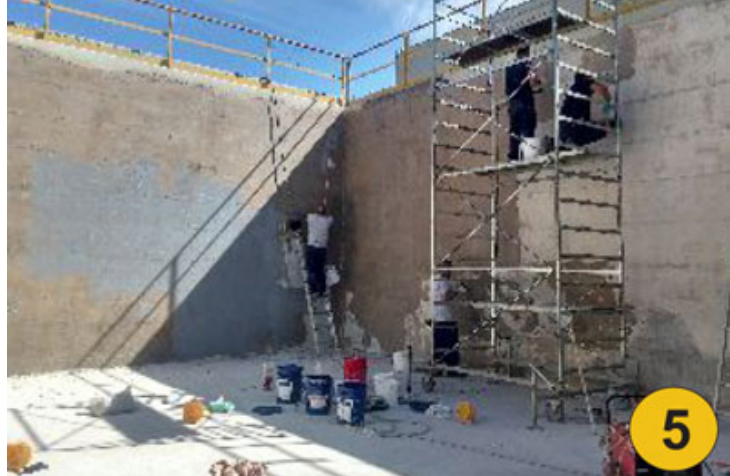
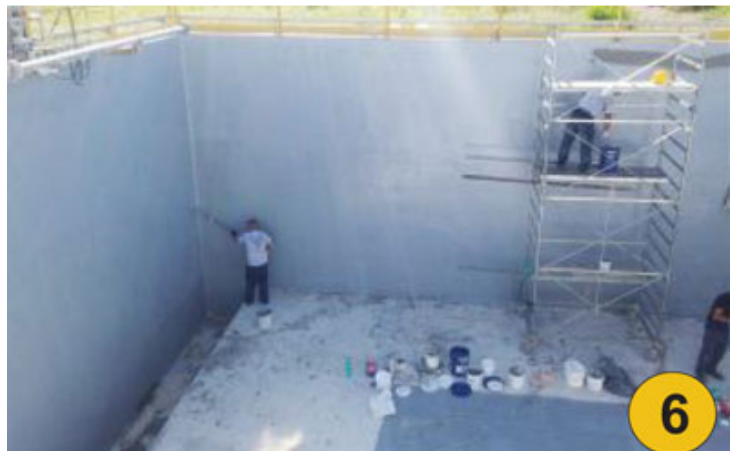
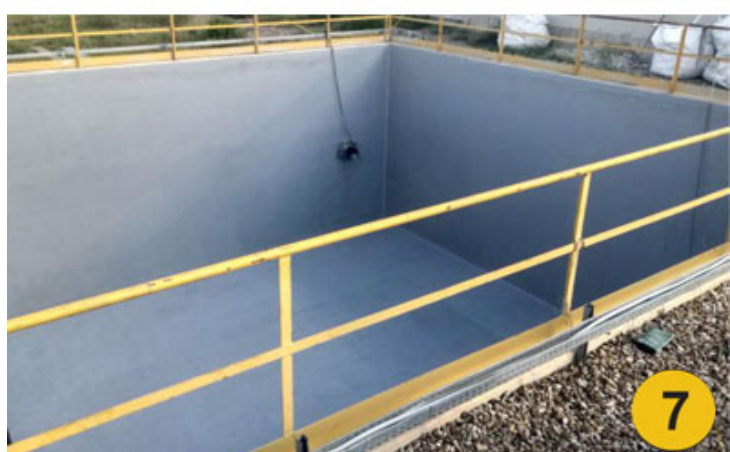
A chemical processing company was storing waste chemical solutions in this large concrete tank. The aggressive nature of the chemicals was attacking the concrete and causing serious damage. The local environmental authority shut the tank down until it had acceptable chemical protection.

The surface was prepared by first removing all dirt, debris and loose concrete. All damaged areas were then repaired with ENECRETE Durafill mixed with a local aggregate.

The repairs to the tank took a total of 8 days; and, when completed, two coats of CHEMCLAD SC were applied by roller to completely protect the tank.
