Enecon North East News
 Oct 2013 | Vol 5, Issue 10

Enecon Eneseal CR

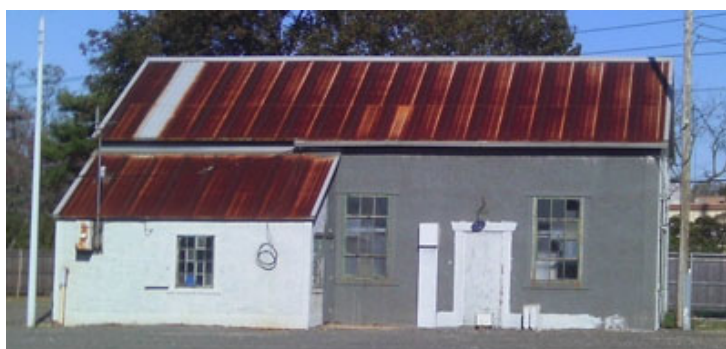
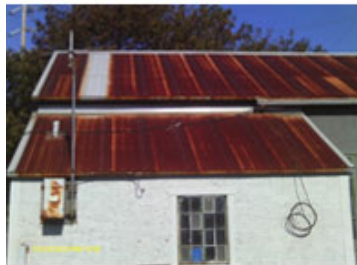
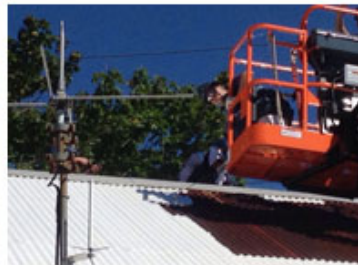
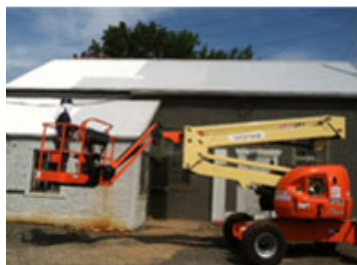
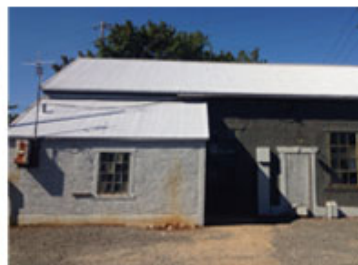
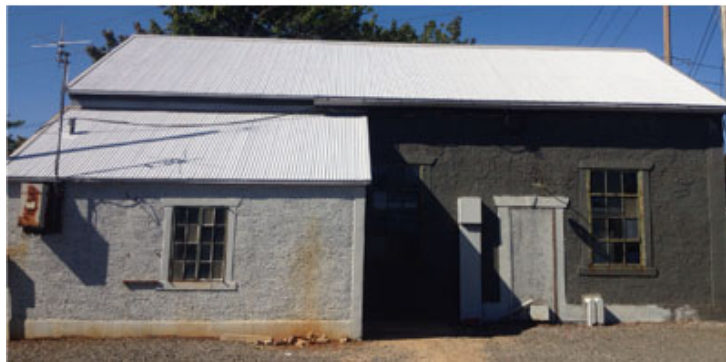
A National Power company had requested a proposal for the application of the **ENECON** weatherproofing and sealing system to the roof sections of the switchgear storage building located at a local Substation. This building had a corrugated metal roof that had started to severely corrode causing a potential for leaks and an unsightly condition that neighbors had complained about. The building included approximately 1800 SF of roof area (with the corrugations adding 25% more area to be coated). The company wanted to eliminate the rust condition and improve the appearance of the structure. The application of the **ENECON ENESEAL CR** weatherproof coating to the entire roof accomplished both goals.

ENECON Northeast APS accomplished basic surface preparation to ensure that the roof surfaces were clean, lightly roughened and dry. For this application, the corrugated roof was pressure washed and coated using a boom truck to keep traffic on the roof to a minimum.

A three layer, flexible coating system was then applied using **ENECON ENESEAL CR**, a one component, corrosion inhibited, water based weatherproofing copolymer. The **ENESEAL** systems create a highly flexible, joint bridging, breathable, seamless, "skin" that provides excellent weather and UV resistance.
