Enecon North East News
 Apr. 2018 | Vol 10, Issue 3

Steel Mill Submersible Pumps Protected With CHEMCLAD

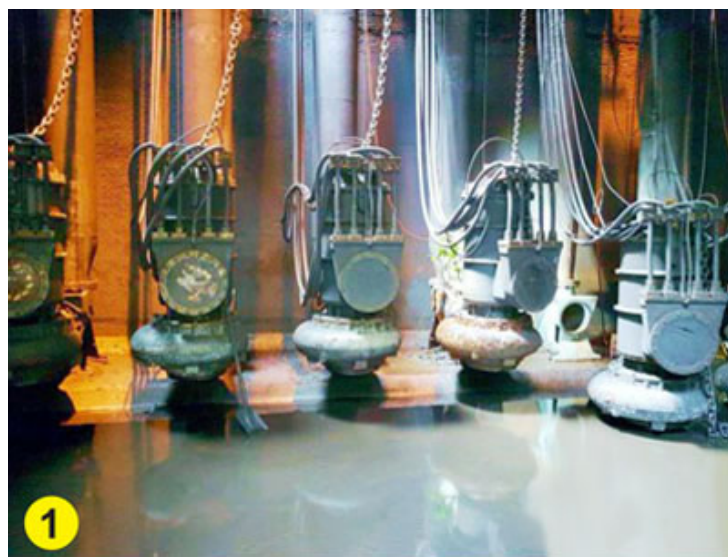
All the recycled water from the descaling process at a steel mill ends up in a large, underground pit. The submersible pumps inside the pit push the water back up through strainers so it can be pumped to other parts of the mill.

Due to the highly corrosive nature of the water in the pit, the pumps do not have a very long working life before they need to be reconditioned. The large pump motor casings would often develop holes from the corrosion/chemical attack, allowing water to get inside causing them to stop working..

When the pumps stopped working not only was production affected, but the repair bill for the motors was extremely costly. Typically, a 3-coat paint system would be applied to "protect" the pumps, however every year the paint would fail and the pumps would have to be re-coated. Forward thinking managers from the maintenance and electrical departments of the mill tested CHEMCLAD XC on the outer casing of one pump.

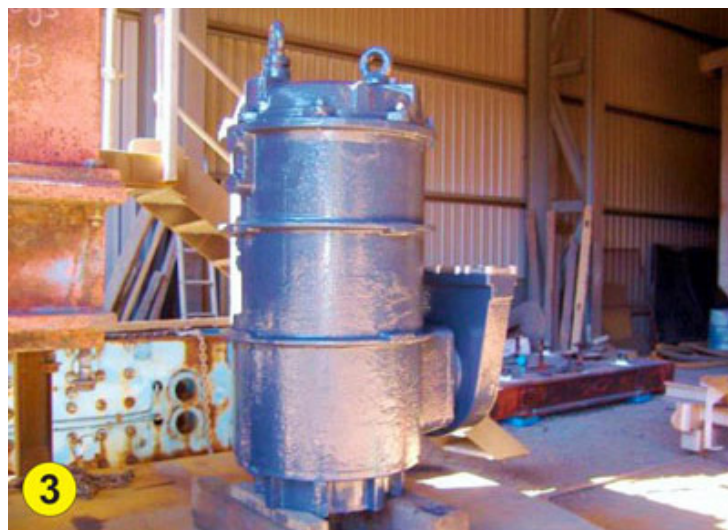
After twelve months the pump was removed from the pit and, although covered with residue, the CHEMCLAD XC was still in perfect condition.

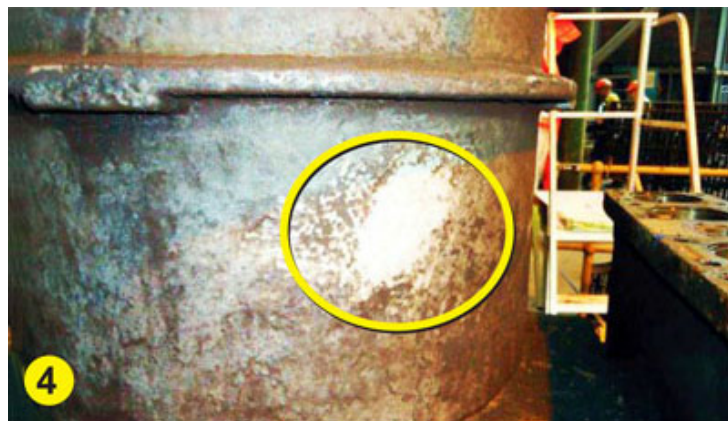
Instead of having to re-paint the motor, it was simply put back into service. After this successful trial, all of the pumps have since been protected with CHEMCLAD XC. The maintenance team was quick to highlight the long term benefits of this application: no costly breakdowns due to chemical attack/corrosion, no ingestion of water into expensive electrical windings of the pump motors, and no need to continuously re-coat the entire unit.
